ADDENDUM 01

RFP 21-200

Terry Day House Lease Agreement

Architectural, Structural, and Environmental Study of Pat & Terry Day House

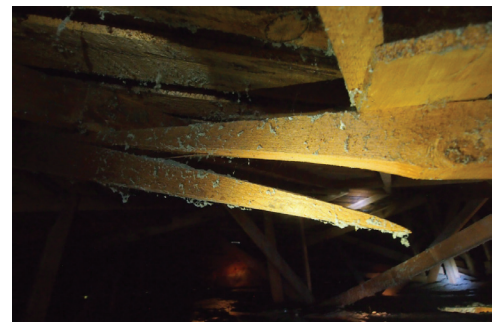
Broken joist

struts bearing on questionable supports. Several of the joist and supports were found to be broken or split.

To replace the roof structure is probably the best solution relative to the issues with the existing roof.

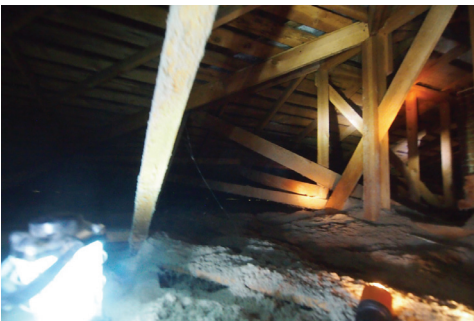
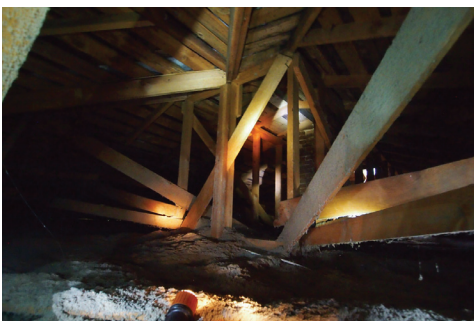
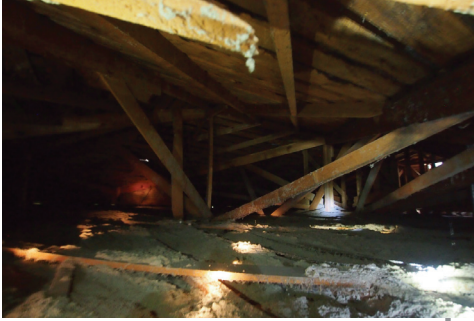
The asphalt roof shingles are beyond their life span and the low slope of the roof is exacerbating this deterioration. The roof structure is made of a random, chaotic, combination of joists with often low slope diagonal

Roof framing

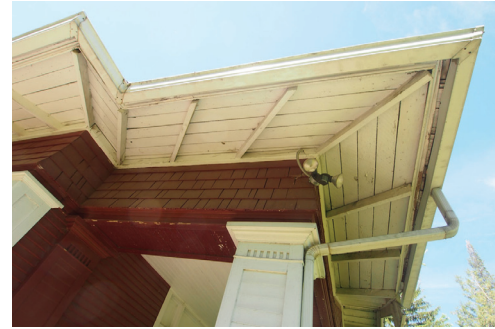
At the north porch the roof framing joists radiate the angle of the valleys of the gable dormer over the front porch. This framing mythology creates very long unsupported lengths as the joist is spanning a much longer distance than needed in typical framing.

Radial joists at front porch

Because of this peculiar framing, the rafter tails which are exposed on the exterior create a unique design which might be only found on this building. Replicating this condition will need to be evaluated and discussed.

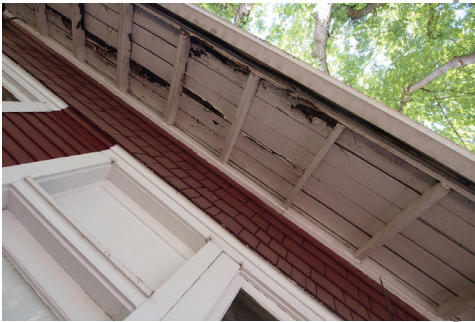
Dry rot at Eave

By replacing the roof structure, the dry rot found in the eaves, as well as pest control noted in the Structural Report will be resolved.

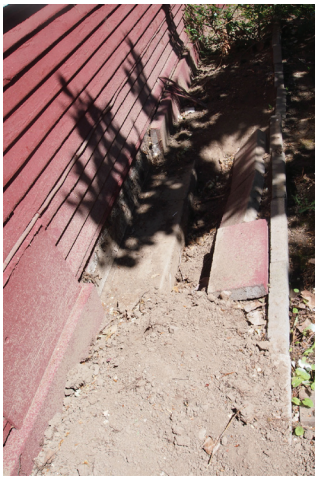
Bottom of wall at grade

Grade Elevation to Sole Plate Framing will need to be looked into with some destructive openings to expose suspect conditions for viewing and analysis. There are common reconstruction techniques and methods for restoring, or repairing, these possible conditions including simple replacement.

The distance from untreated wood to grade as mentioned in the Structural Report as well as Mr. Walter's letter can be resolved by regrading, but given the "flatness" of the site, there is not a lot of slope available to work with. An additional sometimes used method is to install clean gravel around the base of the building. The building code allows a shorter height for this gravel condition than for typical soil. The gravel edge can also double as a mow strip.

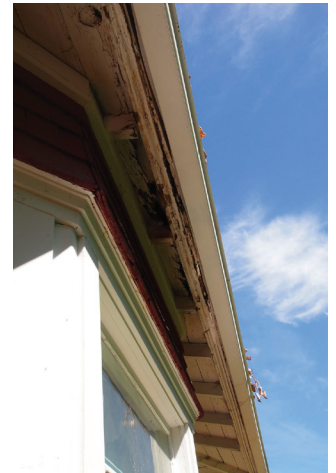
Dry rot at eave

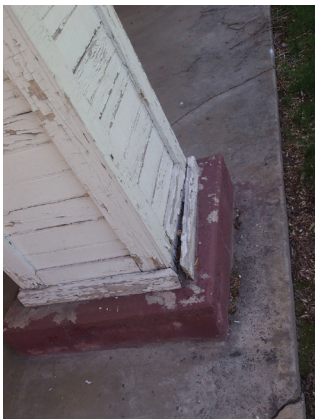
Porch Column base

Front Porch Columns are in need of reconstruction and/or replacement. This will also require potential replacement of the concrete slab and supporting column foundations (if any). Some of the siding material used to enclose the structural elements of these columns may be able to be salvaged, but it is often easier and less expensive to replicate these materials with new. This is common and easy to do.

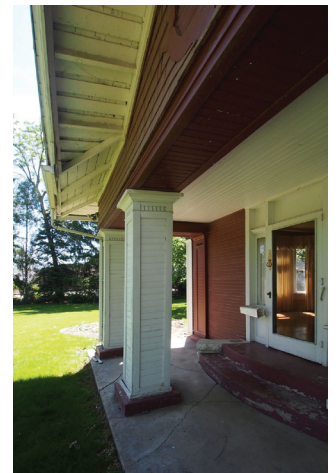
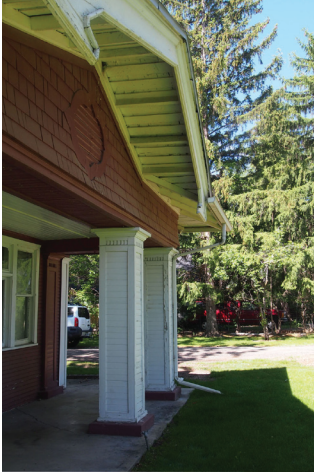
Porch Columns

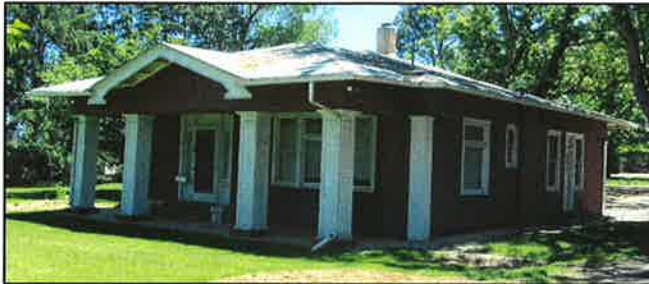
1. The most pronounced issue is the front porch settlement and leaning columns. It appears that the concrete porch was placed on inadequate soils, has cracked, settled and migrated away from the main structure. At the easternmost porch column the bottom is over 3" out of plumb from the top and has subsequently dropped the header about an inch. Additionally, the columns are rotting out at the bottom.
2. Next it was observed that, especially on the east side of the house, the earth and vegetation is almost at the level of the wood plate and floor framing above the basement walls. The wood was moist and 'punky' in some locations. Concrete pavers set on edge are placed up against

Front Porch

1. The front porch needs substantial repair to prevent further decay and possible collapse. In short, the entire porch roof structure should be jacked up to a level condition and shored. The columns can then be cut free of their connection to the concrete base and supported. The

rotted ends of the columns and finishes should then be properly replaced. The existing footings and surrounding cracked concrete slab should be removed, being careful to keep the historic entry steps intact. Once competent soil is exposed at least 24" below the finished grade, new reinforced footings and slab should be poured. Hardware should be used to not only secure the columns to the concrete, but also to keep them separated from moisture-harming contact.

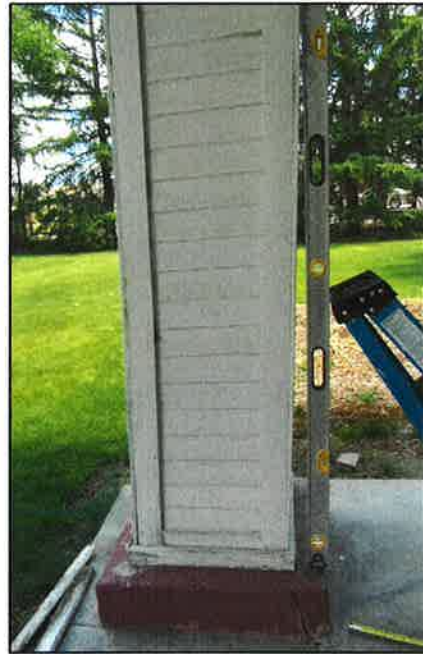
Out of Plumb Porch Columns

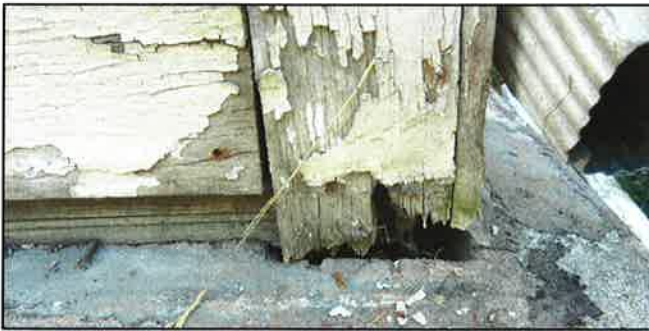
Rotted Porch Columns

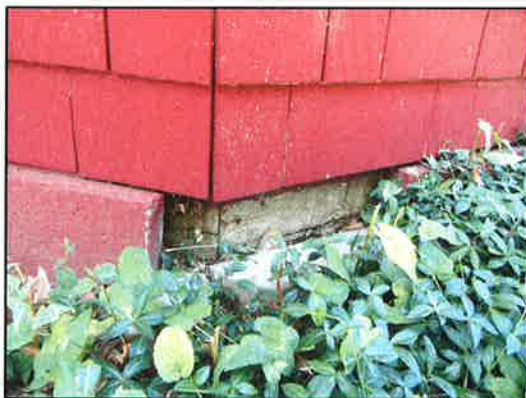
Vegetation at Sill Plate

2. The soil on the east side of the residence is too close to the wood mud sill and should be lowered to expose at least 6" of the concrete foundation wall. The surrounding ground surface should be graded such that a 2% slope away from the house exists, for a minimum of 10'. Rotted boards should be identified and replaced.

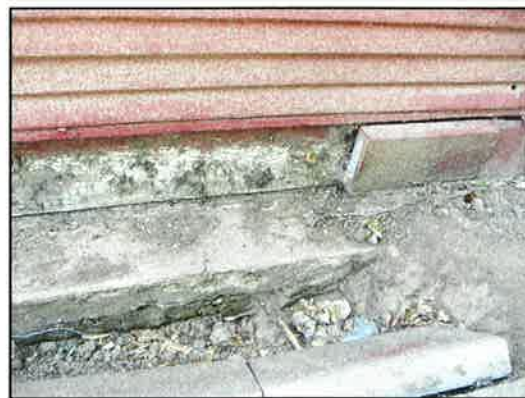
Soil at Sill Plate Level

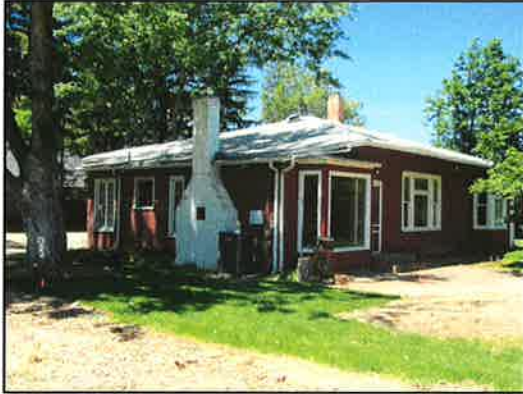
3. The roof is sagging substantially in some areas. At the kitchen addition roof, the low slope, combined with the sagging rafters, creates a condition such that the roofing type (asphalt 3 tab shingles) warranty would most likely be voided. Driving rain and obstructed melting snow could find its way into the attic space, though no evidence of current leaks was observed. Additionally there is a large hump in the roof near the southwest corner. This is most likely at a location where there is something solid preventing uniform roof sag.

Sagging Roof

3. The roof framing has many issues of which repairs would be very costly. It is recommended that the existing sagging roof with its undefined bearing conditions be completely removed and replaced with modern wood trusses that span between defined bearing locations. This work should be accomplished as to leave the existing ceiling joists and ceiling treatments in place. Historic eave character could be recreated. Alternately, it is feasible to jack up and re-support and repair the existing roof structure, but access and complexity do not favor this approach.

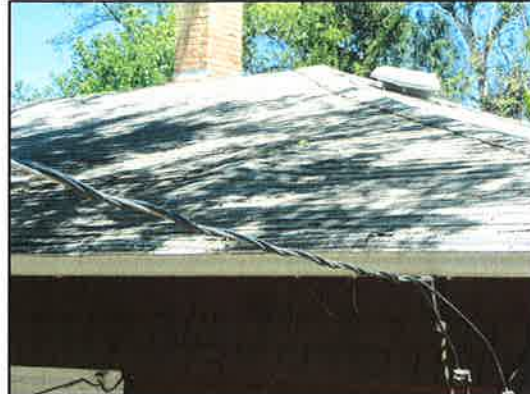
Hump in Roof

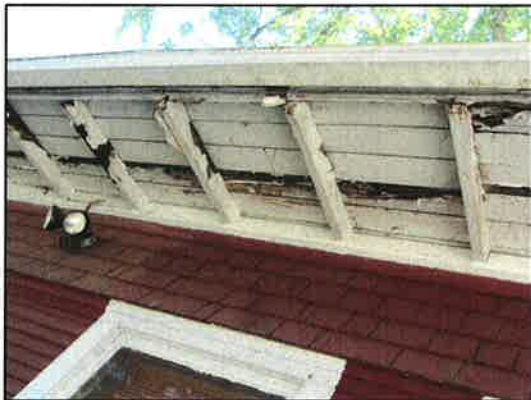
4. There are several roof eaves where the paint has given way to rotting wood soffit boards. The fact that the underside, which is protected from rain, is so damaged suggests that ice dams at the roof edge are causing water to seep under the shingles to the wood sheathing.

Water Damaged Soffit Boards

4. The rotted eaves and soffit boards should be removed and replaced. This could be part of #3 above if new trusses are installed. The new soffits should be primed and painted for this outdoor environment.

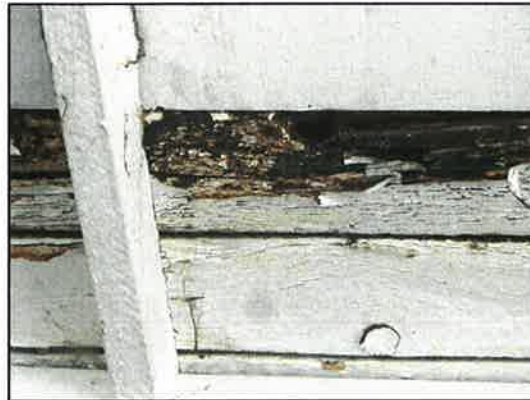
Water Damage
