FLH CULVERT ASSESSMENT FORM

Inspection Report / Inspection: 1

Date 5/18/2011	P/O. No.	Weather Dry	Surveyor's Name JOEL vASEY	Pipe Segment Reference	Section No. 3
Certificate No. u-304-1198	Survey Customer	System Owner	Date Cleaned	Pre-Cleaning No Pre-Cleaning	Sewer Category

Street 346+13	Use of Sewer Stormwater	Upstream MH INLET-W
City Port Angeles	Drainage Area	Downstream MH OUTLET
Loc. details	Flow Control	Dir. of Survey Downstream
Location Code	Length surveyed 69.92 ft	Section Length 69.92 ft

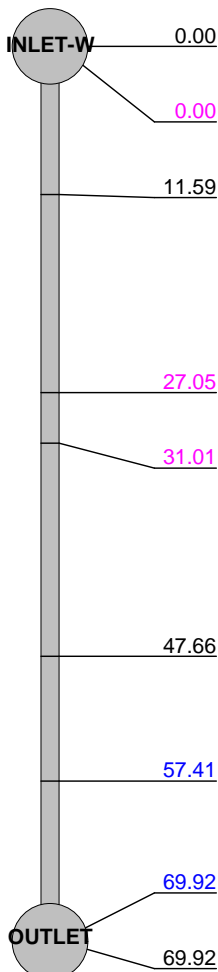
0.00	End of Pipe / INLET-W	00:00:00				
	0.00	S1 Deposits Settled Gravel, 30 %of cross sectional area, from 04 to 08 o'clock, , within 8 inches of joint: YES, Start	00:00:44

11.59	Infiltration Stain, at 03 o'clock, within 8 inches of joint: YES	00:04:33				
	27.05	Deformed, 10 % / DENT@7:00	00:08:19				
	31.01	F1 Deposits Settled Gravel, 30 %of cross sectional area, from 04 to 08 o'clock, , within 8 inches of joint: YES, Finish	00:09:37

47.66	Infiltration Stain, from 05 to 07 o'clock, within 8 inches of joint: YES	00:14:35				
	57.41	S2 Deposits Settled Gravel, 5 %of cross sectional area, from 05 to 07 o'clock, , within 8 inches of joint: YES, Start	00:16:20

69.92	F2 Deposits Settled Gravel, 5 %of cross sectional area, from 05 to 07 o'clock, , within 8 inches of joint: YES, Finish	00:18:42				
	69.92	End of Pipe / OUTLET	00:18:49				
QSR	QMR	SPR	MPR	OPR	SPRI	MPRI	OPRI
4100	4623	4	30	34	4	3.33	3.4
