1011  
ALASKA  
Job Corps Center  
Palmer, AK

Facility Planning Report  
Volume I  
Planning Strategy

Final  
May 2016

Department of Labor/ Office of Job Corps

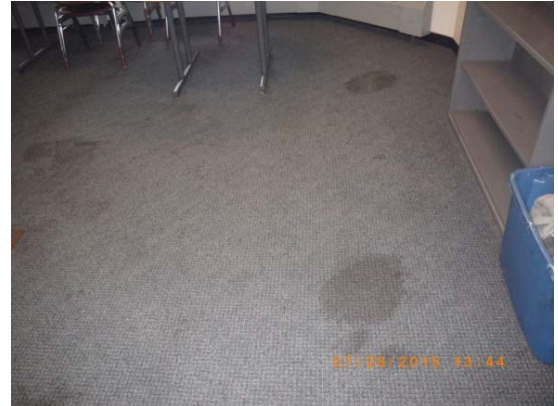
- The flooring in Male Dormitory Building 6 and Female Dormitory Building 7 is worn in the corridors, lounges, dormitory rooms, and Residential Advisor (RA) offices.
- Vacant Building 9 (trailers) is vacant, in fair condition, and no longer required on Center after construction of the Wall Hall Vocational Annex Building 11.

- The original cedar siding on the 1994 Center **Typical Damaged Carpeting in Dormitories** buildings is worn and needs to be repaired and re-stained.
- The Protective Services Classroom, recently moved to the former Heavy Equipment Classroom in Building 3, is undersized, and not designed for the Protective Services vocation.

A Regional project would replace all the floor finishes (including carpeting and vinyl composite tile (VCT)) in the Male and Female dormitory (Building 6 and 7) lounges, corridors, dormitory room, common spaces, and utility rooms, with new flooring material by using sheet linoleum or carpet tiles. This would improve the overall appearance of the dormitories and provide a more durable finish in high traffic areas.

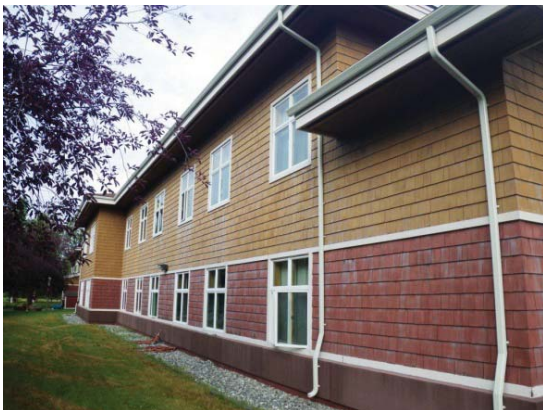
**Worn Cedar Siding Paint on Building 7**

NATIONAL PROJECT # 3704  
REPAINT EXTERIOR SIDING  
OF CENTER BLDG'S  
1, 2, 3, 4, 5, 6, 7 & 8

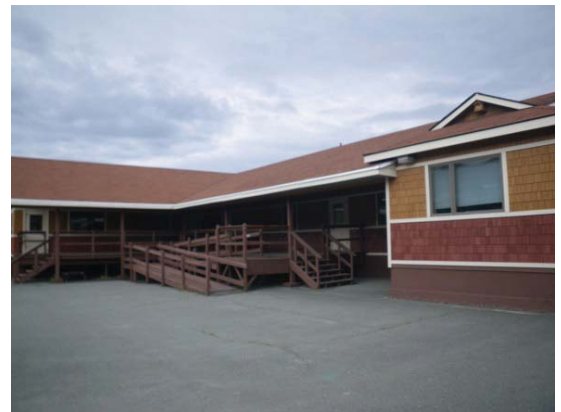
**Building 9 to be Demolished**

A Regional project would demolish Vacant (Trailers) Building 9 (formerly Vocational Annex) which will reduce the amount of excess square footage on Center.
