# WATERFRONT STRUCTURES AT WHITE BEACH FUEL PIER AND TENGAN SMALL CRAFT BERTH 2018 INSPECTION

## 1. EXECUTIVE SUMMARY

**General Project Description:** The U.S. Army Corps of Engineers (USACE) Dive Team performed a visual and tactile inspection of all above water and underwater waterfront structures and adjacent bank lines of the berthing areas at the White Beach Fuel Pier and Tengan Small Craft Berth and Seawalls in Okinawa, Japan, from April 5 to 18 2018. The structures inspected included: 1,728 LF of Fuel Pier, 250 ft of tetrapod wave protection on the shore end of the pier at White Beach, and 1,200 LF of tetrapod protected concrete seawall, 2100 SF of boat ramp, 800 LF of pile and cap wall, 225 LF of coral/stone wall and 186 LF of concrete block wall at the Tengan Small Craft Basin and Seawalls.

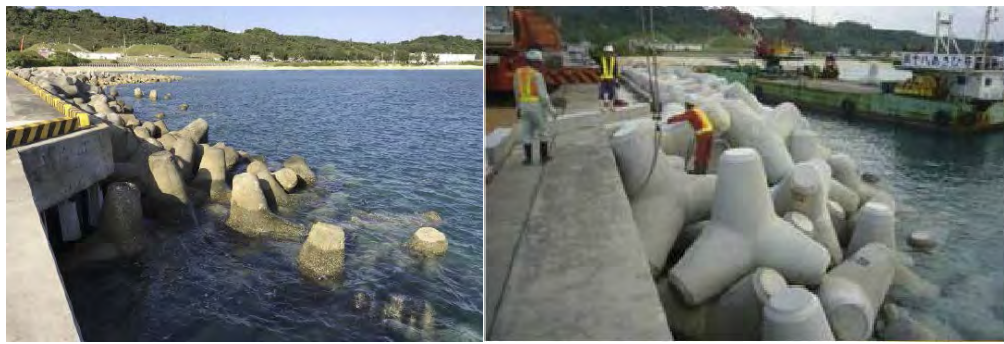
Insert 6-1. Tetrapods at White Beach Fuel Pier, 3 Nov 2007 (L) and 2 April 2018 (R)

The unknitting of the tetrapods is a result of the toe of the armor layer being constructed on a remnant SSP wall at Station 0+50. This SSP has deflected seaward, allowing the tetrapods to shift and reducing their resistance to wave action. This deterioration will continue and requires the SSP to be cutoff and the tetrapods reset and properly knit together with a stable toe. The tetrapods have shifted significantly since installation, as shown in Insert 6-1.

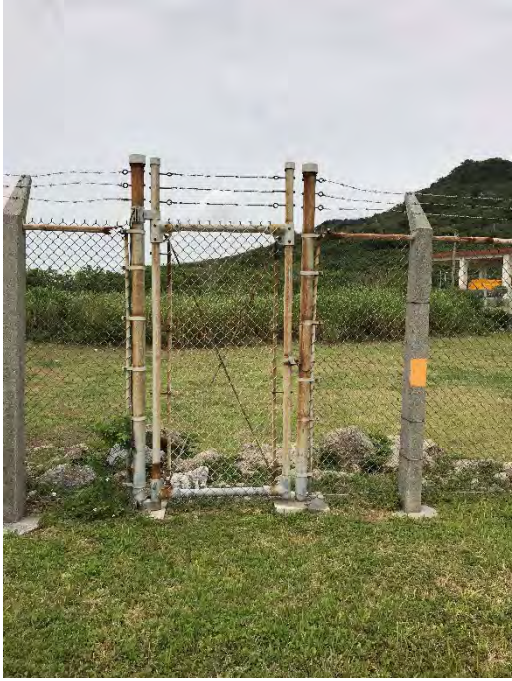
<p><b>Client Name:</b> White Beach Fuel Pier Okinawa, Japan</p>	
<p><b>Date:</b> 4/16/18</p>	
<p><b>Site Location:</b> White Beach Causeway</p>	
<p><b>Photo No:</b> 1</p>	
<p><b>Description:</b> Sta. -6+30A – Minor corrosion, steel man gate posts</p>	
<p><b>PHOTOLOG SHEET</b></p>

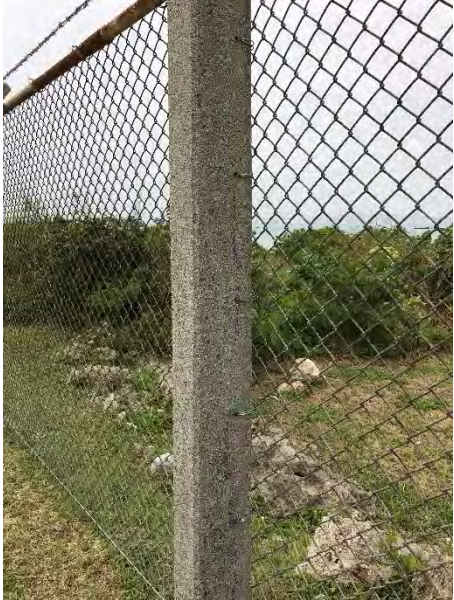
<p><b>Client Name:</b> White Beach Fuel Pier Okinawa, Japan</p>	
<p><b>Date:</b> 4/16/2018</p>	
<p><b>Site Location:</b> White Beach Causeway</p>	
<p><b>Photo No:</b> 2</p>	
<p><b>Description:</b> Sta. -5+70A – Cracked fence post</p>

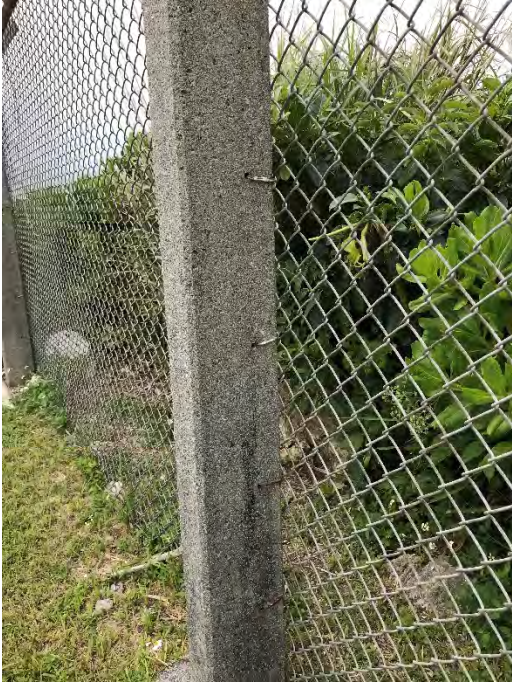
<p><b>Client Name:</b> White Beach Fuel Pier Okinawa, Japan</p>	
<p><b>Date:</b> 4/16/18</p>	
<p><b>Site Location:</b> White Beach Causeway</p>	
<p><b>Photo No:</b> 3</p>	
<p><b>Description:</b> Sta -5+10A – Cracked fence post</p>	
<p><b>PHOTOLOG SHEET</b></p>

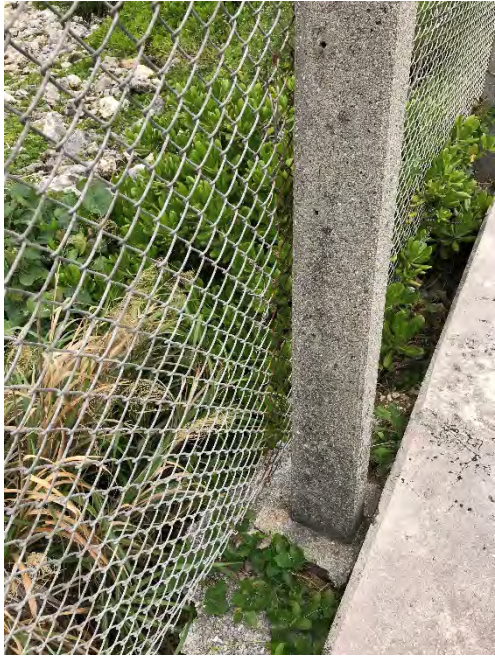
<p><b>Client Name:</b> White Beach Fuel Pier Okinawa, Japan</p>	
<p><b>Date:</b> 4/16/18</p>	
<p><b>Site Location:</b> White Beach Causeway</p>	
<p><b>Photo No:</b> 4</p>	
<p><b>Description:</b> Sta. -4+60A – Missing wire for mesh</p>

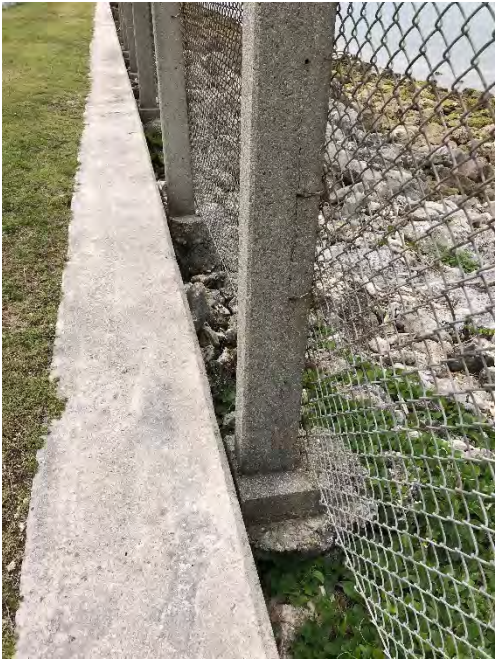
<p><b>Client Name:</b> White Beach Fuel Pier Okinawa, Japan</p>	
<p><b>Date:</b> 4/16/18</p>	
<p><b>Site Location:</b> White Beach Causeway</p>	
<p><b>Photo No:</b> 5</p>	
<p><b>Description:</b> Sta. -4+50A - Cracked fence post with loose chain mesh</p>	
<p><b>PHOTOLOG SHEET</b></p>

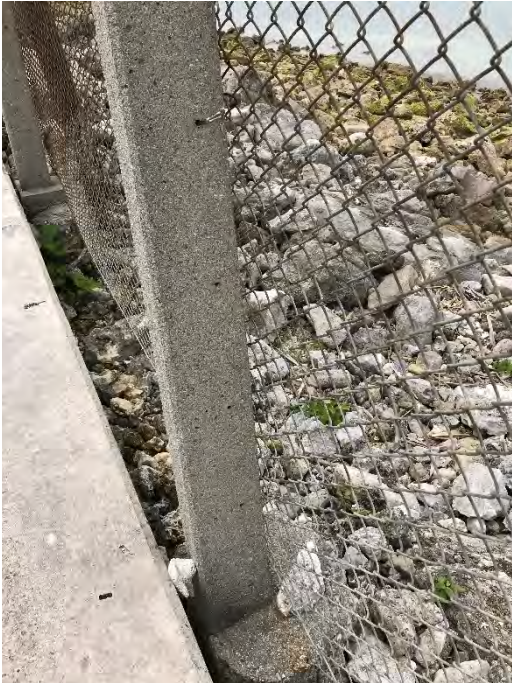
<p><b>Client Name:</b> White Beach Fuel Pier Okinawa, Japan</p>	
<p><b>Date:</b> 4/16/18</p>	
<p><b>Site Location:</b> White Beach Causeway</p>	
<p><b>Photo No:</b> 6</p>	
<p><b>Description:</b> Sta. -4+40A – Missing wire for mesh and displaced foundation</p>

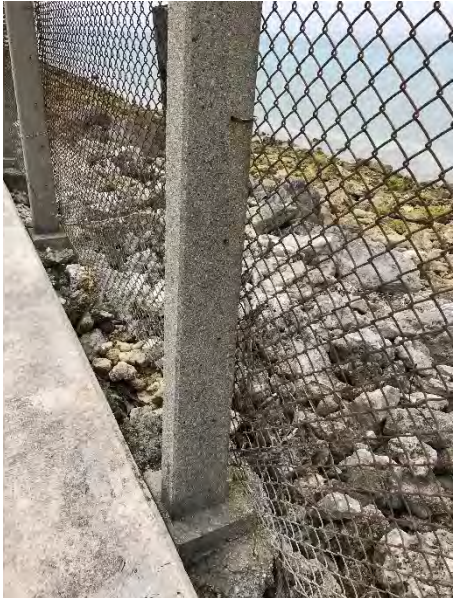
<p><b>Client Name:</b> White Beach Fuel Pier Okinawa, Japan</p>	
<p><b>Date:</b> 4/16/18</p>	
<p><b>Site Location:</b> White Beach Causeway</p>	
<p><b>Photo No:</b> 7</p>	
<p><b>Description:</b> Sta. -4+30A – Missing wire for mesh</p>	
<p><b>PHOTOLOG SHEET</b></p>

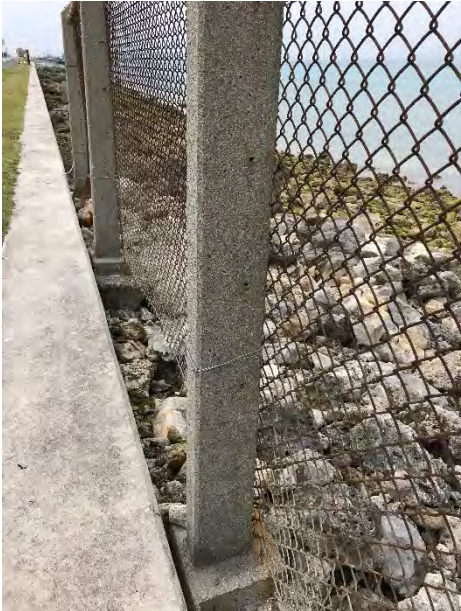
<p><b>Client Name:</b> White Beach Fuel Pier Okinawa, Japan</p>	
<p><b>Date:</b> 4/16/18</p>	
<p><b>Site Location:</b> White Beach Causeway</p>	
<p><b>Photo No:</b> 8</p>	
<p><b>Description:</b> Sta. -4+20A – Missing wire for mesh</p>

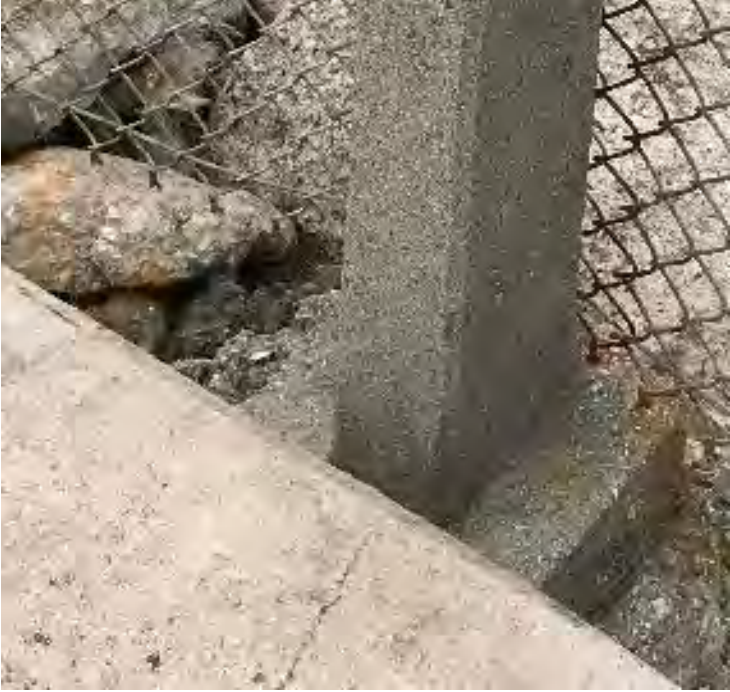
<p><b>Client Name:</b> White Beach Fuel Pier Okinawa, Japan</p>	
<p><b>Date:</b> 4/16/18</p>	
<p><b>Site Location:</b> White Beach Causeway</p>	
<p><b>Photo No:</b> 10</p>	
<p><b>Description:</b> Sta. -4+10A – Horizontal Crack in PC</p>

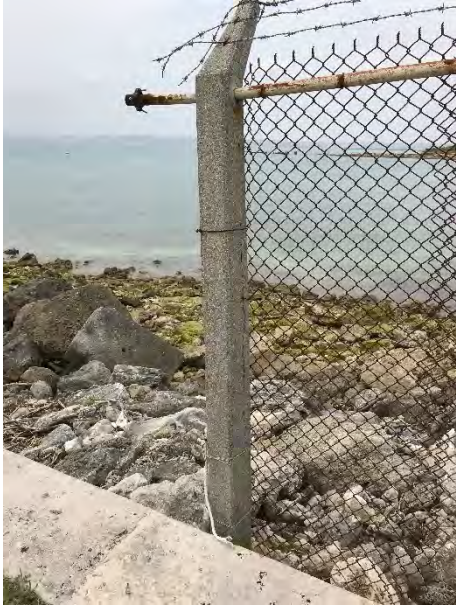
<p><b>Client Name:</b> White Beach Fuel Pier Okinawa, Japan</p>	
<p><b>Date:</b> 4/16/18</p>	
<p><b>Site Location:</b> White Beach Causeway</p>	
<p><b>Photo No:</b> 11</p>	
<p><b>Description:</b> Sta. -4+00A - Cracked fence post with loose chain mesh</p>	
<p><b>PHOTOLOG SHEET</b></p>

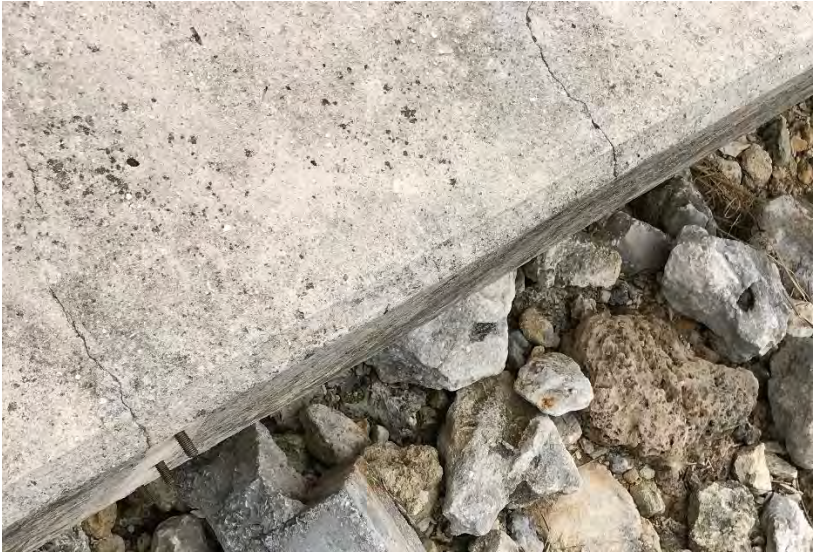
<p><b>Client Name:</b> White Beach Fuel Pier Okinawa, Japan</p>	
<p><b>Date:</b> 4/16/18</p>	
<p><b>Site Location:</b> White Beach Causeway</p>	
<p><b>Photo No:</b> 12</p>	
<p><b>Description:</b> Sta. -3+95A – 2 x Horizontal Crack in PC</p>

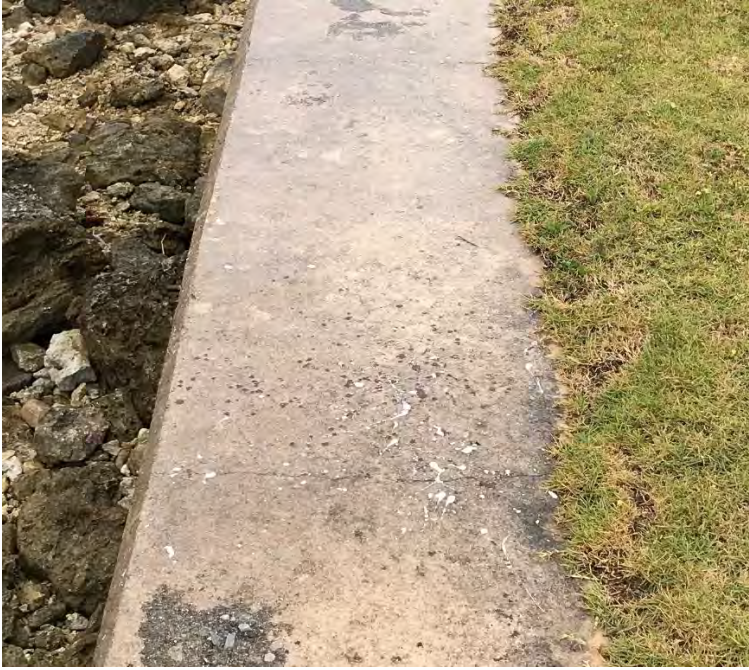
<p><b>Client Name:</b> White Beach Fuel Pier Okinawa, Japan</p>	
<p><b>Date:</b> 4/16/18</p>	
<p><b>Site Location:</b> White Beach Causeway</p>	
<p><b>Photo No:</b> 13</p>	
<p><b>Description:</b> Sta. -3+85A – Horizontal Crack in PC</p>

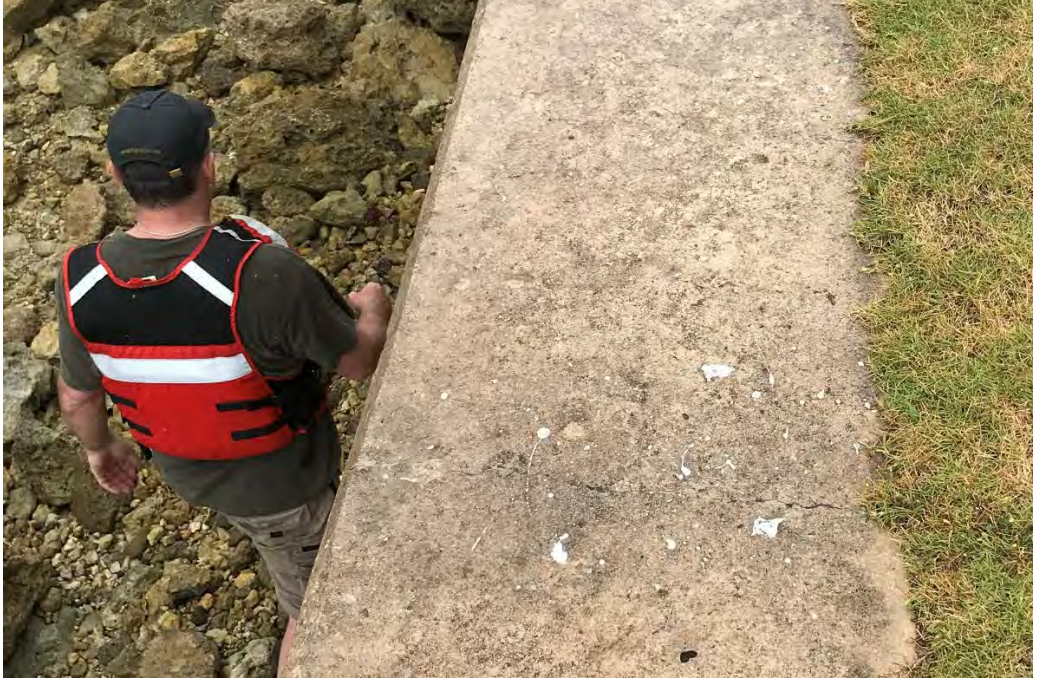
<p><b>Client Name:</b> White Beach Fuel Pier Okinawa, Japan</p>	
<p><b>Date:</b> 4/16/18</p>	
<p><b>Site Location:</b> White Beach Causeway</p>	
<p><b>Photo No:</b> 14</p>	
<p><b>Description:</b> Sta. -3+75A – Horizontal Crack in PC</p>

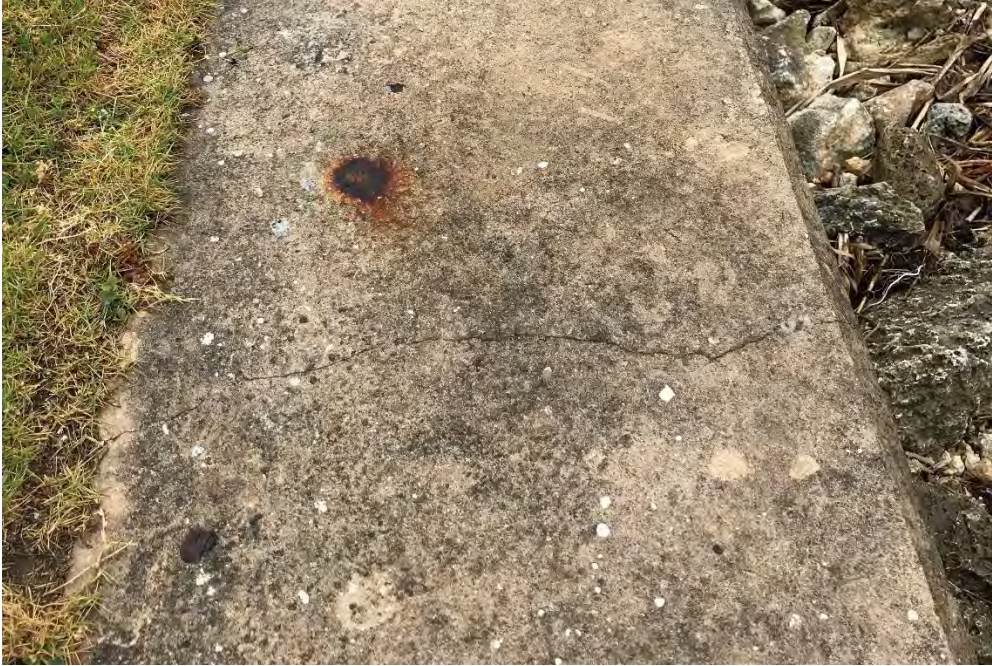
<p><b>Client Name:</b> White Beach Fuel Pier Okinawa, Japan</p>	
<p><b>Date:</b> 4/16/18</p>	
<p><b>Site Location:</b> White Beach Causeway</p>	
<p><b>Photo No:</b> 15</p>	
<p><b>Description:</b> Sta. -3+80A – Horizontal Crack in PC</p>	
<p><b>PHOTOLOG SHEET</b></p>

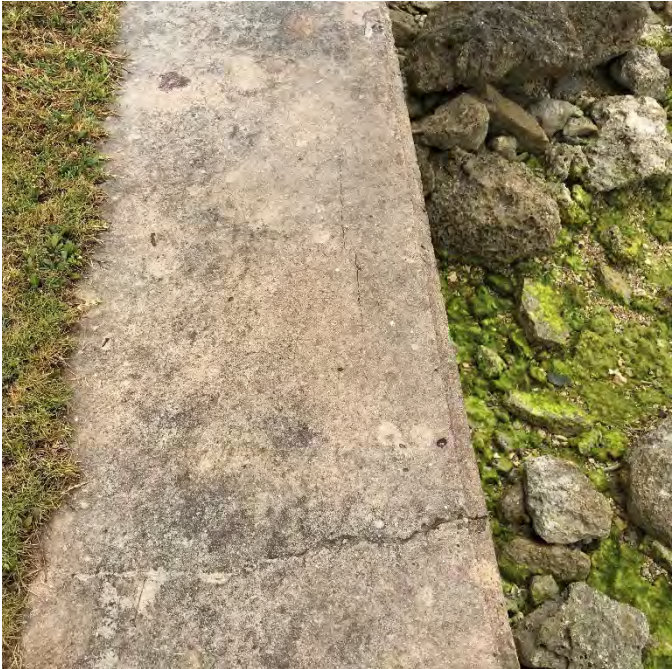
<p><b>Client Name:</b> White Beach Fuel Pier Okinawa, Japan</p>	
<p><b>Date:</b> 4/16/18</p>	
<p><b>Site Location:</b> White Beach Causeway</p>	
<p><b>Photo No:</b> 16</p>	
<p><b>Description:</b> Sta. -3+10A – 2 x Horizontal Crack in PC</p>
