# FLH CULVERT ASSESSMENT FORM

## Inspection Report / Inspection: 1

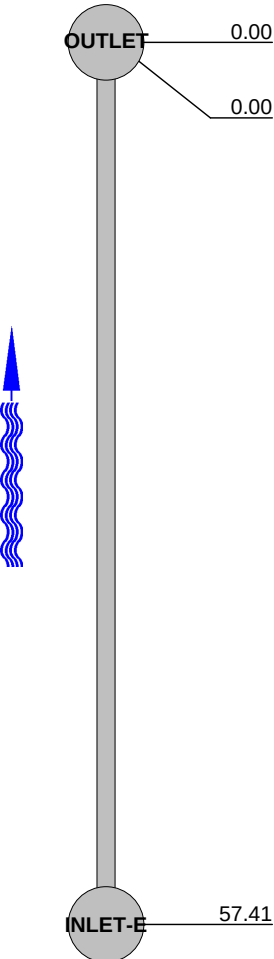
| 1:150 | Position | Observation | MPEG | Photo | | | |
|---|---|---|---|---|---|---|---|
| | 0.00 | End of Pipe / OUTLET-W | 00:00:41 | | | | |
| | 0.00 | Water Level, 5 %of cross sectional area | 00:00:44 | | | | |
| | 57.41 | End of Pipe / INLET-E | 00:05:42 | | | | |
