# FLH CULVERT ASSESSMENT FORM

## Inspection Report / Inspection: 1

| Street<br><b>153+25</b> | Use of Sewer<br><b>Stormwater</b> | Upstream MH<br><b>INLET-W</b> |
| City<br><b>Port Angeles</b> | Drainage Area | Downstream MH<br><b>OUTLET</b> |

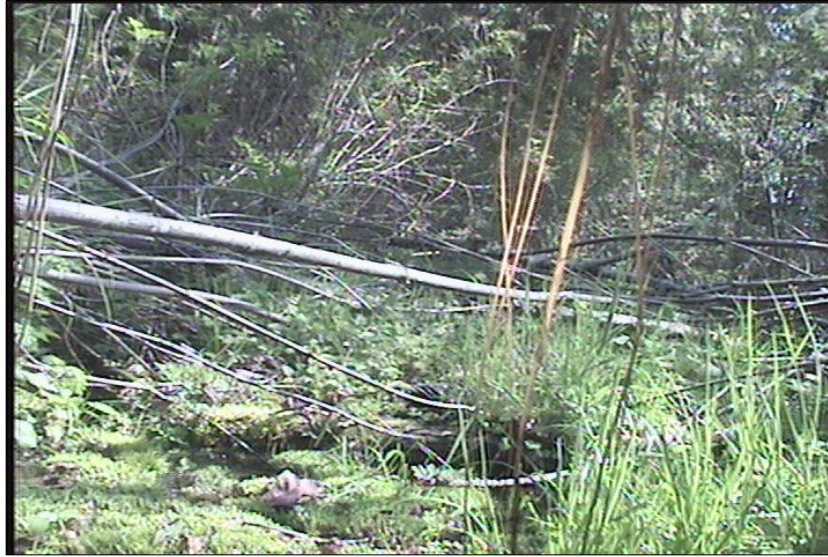
| 1:165 | Position | Observation | MPEG | Photo | | | |
|---|---|---|---|---|---|---|---|
| | 63.12 | End of Pipe / OUTLET | 00:07:49 | INLET-W_OUTLET103021_19<br>052011_A.JPG | | | |

Photo: INLET-W\_OUTLET103021\_19052011\_A.JPG, VCR No.: 1  
63.12FT, End of Pipe
