FLH CULVERT ASSESSMENT FORM

Inspection Report / Inspection: 1

Date 5/18/2011	P/O. No.	Weather Dry	Surveyor's Name JOEL vASEY	Pipe Segment Reference	Section No. 5
Certificate No. u-304-1198	Survey Customer	System Owner	Date Cleaned	Pre-Cleaning No Pre-Cleaning	Sewer Category

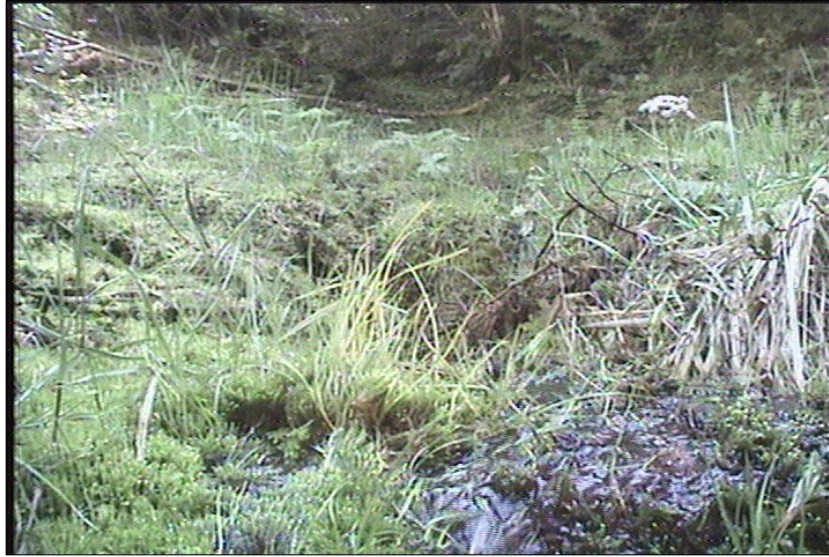
Photo: INLET-W_OUTLET132121_18052011_A.JPG, VCR No.: 1
47.11FT, End of Pipe
