PRESERVATION BRIEFS

22

The Preservation and Repair of Historic Stucco

Anne E. Grimmer

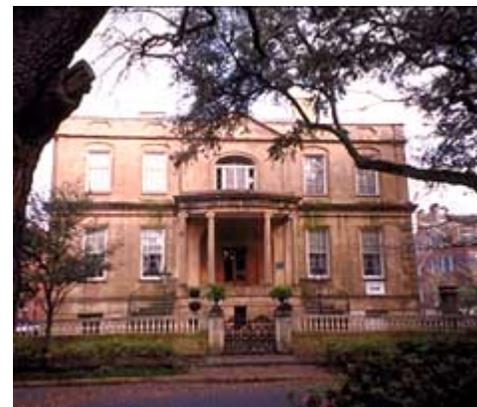
The stucco on the early-19th century Richardson-Owens-Thomas House in Savannah, Georgia, is a type of natural cement. Photo: NPS files.

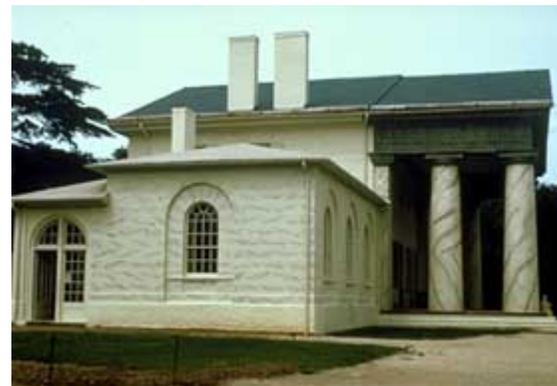
The stucco finish on Arlington House, Arlington, Virginia, was marbled in the 1850s, approximately 30 years after it was built. Photo: NPS files.

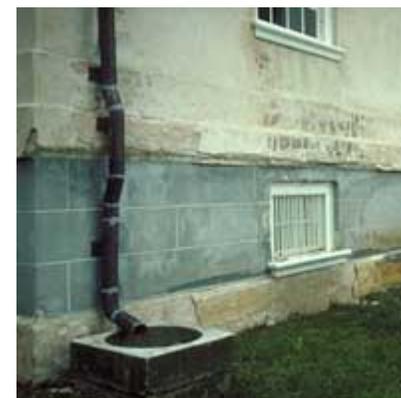
The damage to this stucco appears to be caused by moisture infiltration. Photo: NPS files.

Most stucco deterioration is the result of water infiltration into the building structure, either through the roof, around chimneys, window and door openings, or excessive ground water or moisture penetrating through, or splashing up from the foundation. Potential causes of deterioration include: ground settlement lintel and door frame settlement, inadequate or leaking gutters and downspouts, intrusive vegetation, moisture migration within walls due to interior condensation and humidity, vapor drive problems caused by furnace, bathroom and kitchen vents, and rising damp resulting from excessive ground water and poor drainage around the foundation. Water infiltration will cause wood lath to rot, and metal lath and nails to rust, which eventually will cause stucco to lose its bond and pull away from its substrate.

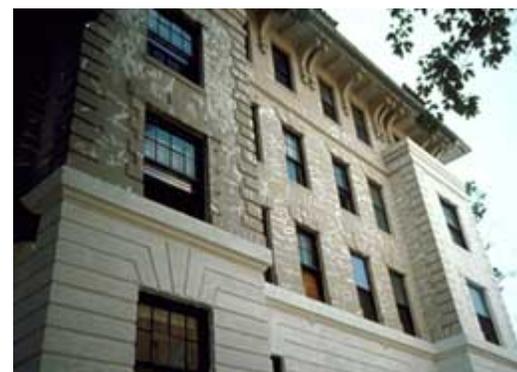
Caulking is not an appropriate method for repairing cracks in historic stucco. Photo: NPS files.

Commercially available caulking compounds are not suitable materials for patching hairline cracks. Because their consistency and texture is unlike that of stucco, they tend to weather differently, and attract more dirt; as a result, repairs made with caulking compounds may be highly visible, and unsightly. Larger cracks will have to be cut out in preparation for more extensive repair. Most stucco repairs will require the skill and expertise of a professional plasterer.

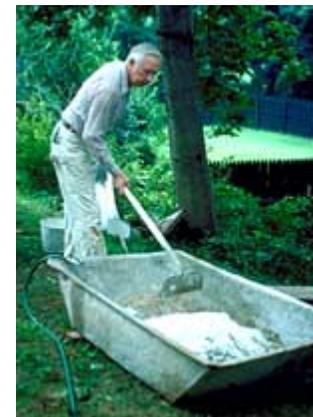
The dry materials must be mixed thoroughly before adding water to make the stucco. Photo: NPS files.

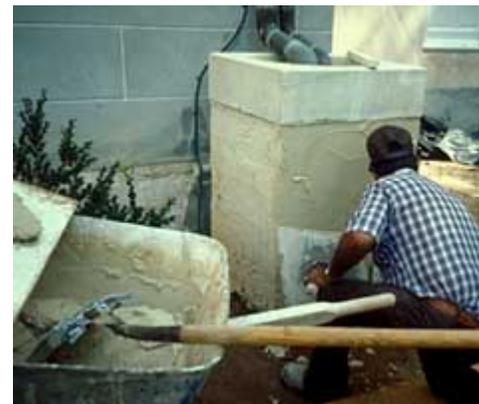
The deteriorated surface of this catch basin is being re-stuccoed. Photo: NPS files.

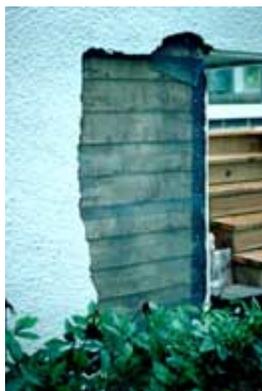
The stucco will be applied to the wire lath laid over the area to be patched. Photo: NPS files.

To ensure a firm bond, the new patch must not overlap the old stucco. If the stucco has lost its bond or key from wood lath, or the lath has deteriorated or come loose from the substrate, a decision must be made whether to try to reattach the old lath, to replace deteriorated lath with new wood lath, or to leave the historic wood lath in place and supplement it with modern expanded metal lath. Unless authenticity is important, it is generally preferable (and easier) to nail new metal lath over the old wood lath to support the patch. Metal lath that is no longer securely fastened to the substrate may be removed and replaced in kind, or left in place, and supplemented with new wire lath.

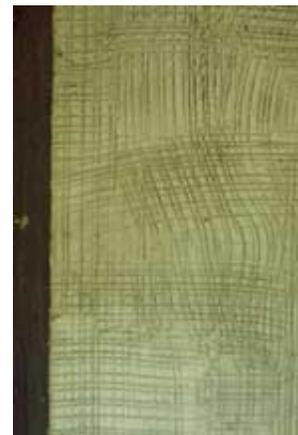
The final finish coat will be applied to this scratch coat. Photo: NPS files.

After thoroughly dampening the masonry or wood lath, the first, scratch coat should be applied to the masonry substrate, or wood or metal lath, in a thickness that corresponds to the original if extant, or generally about 1/4" to 3/8". The scratch coat should be scratched or crosshatched with a comb to provide a key to hold the second coat. It usually takes 24-72 hours, and longer in cold weather, for each coat to dry before the next coat can be applied. The second coat should be about the same thickness as the first, and the total thickness of the first two coats should generally not exceed about 5/8". This second or leveling coat should be roughened using a wood float with a nail protruding to provide a key for the final or finish coat. The finish coat, about 1/4" thick, is applied after the previous coat has initially set. If this is not feasible, the base coat should be thoroughly dampened when the finish coat is applied later. The finish coat should be worked to match the texture of the original stucco.

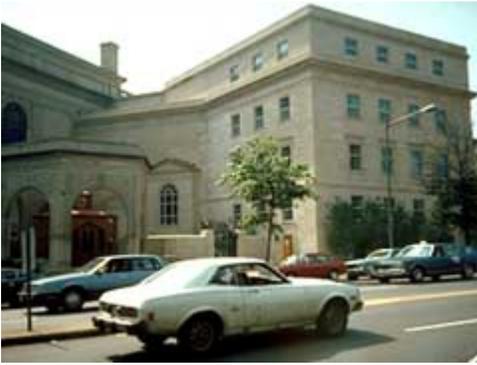
The new addition on the right is stucco scored to imitate the limestone of the historic building on the left. Photo: NPS files.

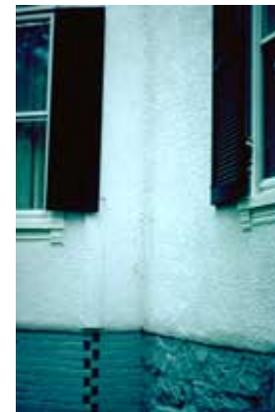
This stucco house has a rough cast finish. Photo: NPS files.

The most common early-twentieth century stucco finishes are often found on bungalow-style houses, and include: spatter or spatterdash (sometimes called roughcast, harling, or wetdash), and pebble-dash or drydash. The spatterdash finish is applied by throwing the stucco mortar against the wall using a whisk broom or a stiff fiber brush, and it requires considerable skill on the part of the plasterer to achieve a consistently rough wall surface. The mortar used to obtain this texture is usually composed simply of a regular sand, lime, and cement mortar, although it may sometimes contain small pebbles or crushed stone aggregate, which replaces one-half the normal sand content. The pebble-dash or drydash finish is accomplished manually by the plasterer throwing or "dashing" dry pebbles (about 1/8" to 1/4" in size), onto a coat of stucco freshly applied by another plasterer. The pebbles must be thrown at the wall with a scoop with sufficient force and skill that they will stick to the stuccoed wall. A more even or uniform surface can be achieved by patting the stones down with a wooden float. This finish may also be created using a texturing machine.
