ADDENDUM 01

RFP 21-200

Terry Day House Lease Agreement

Architectural, Structural, and Environmental Study of Pat & Terry Day House

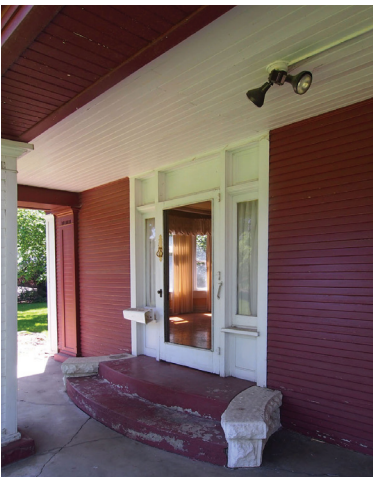
Front porch entry

The front porch roof is supported on four large square columns which rest on a thickened concrete pad or foundation. The flooring of the porch is concrete. The entry steps are stone and concrete.

Front Porch Columns are in need of reconstruction and/or replacement. This will also require potential replacement of the concrete slab and supporting column foundations (if any). Some of the siding material used to enclose the structural elements of these columns may be able to be salvaged, but it is often easier and less expensive to replicate these materials with new. This is common and easy to do.

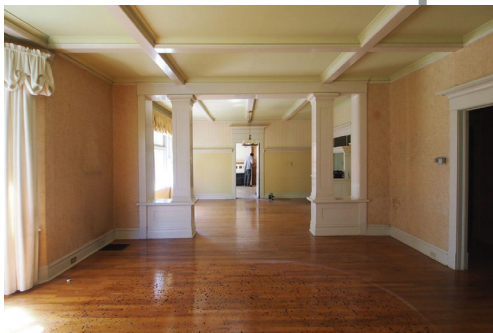
Living Room to dining room

- A finely detailed **Living Room** with a coffered cross beamed or coved ceiling, wood floor, crown molding, and elaborate base boards. The main porch entry is located on the northern wall of this space. There is a built-in wood and glass hutch located in the northeast corner of this space. The walls are wallpapered. There is a large floor to ceiling bay window on the east side. A similarly detailed Dining Room is located to the south. Dividing these two rooms is a symmetrical painted craftsman style column and box framed opening. All the elements within this room are in fine condition.

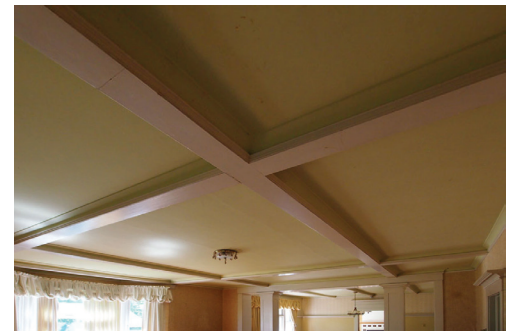
Living Room ceiling

With the exceptions as noted below relative to the structural conditions, the house is in good shape. The exterior walls and siding are sound. The interior floors, walls, and ceilings are all in good shape, with only some small areas that need repair from water damage. There seems to be some distortion of the Dining and Living Room ceilings probably caused by the deteriorating roof structure above.

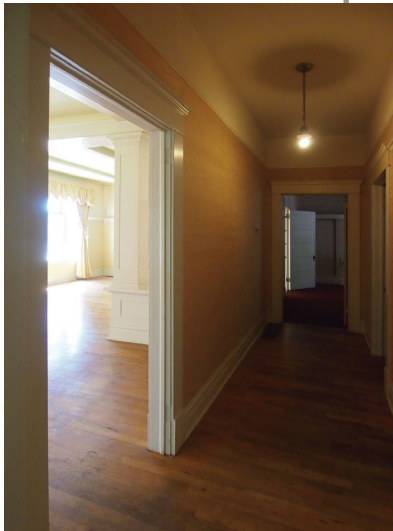
Central hallway

- To the west of the Dining and Living Rooms is a **Central Hallway**. This hallway is accessed from either of these two rooms by a cased opening from the Living Room and a doorway from the Dining Room. From this hallway, doorways lead to the Front Bedroom, Bathroom, Den, and Rear Bedroom. This space is detailed very similar to the previous two rooms with wood floor, wallpaper walls, doors and door frames. There is a picture rail high on all four walls with a painted ceiling. This Central Hallway is in excellent condition.

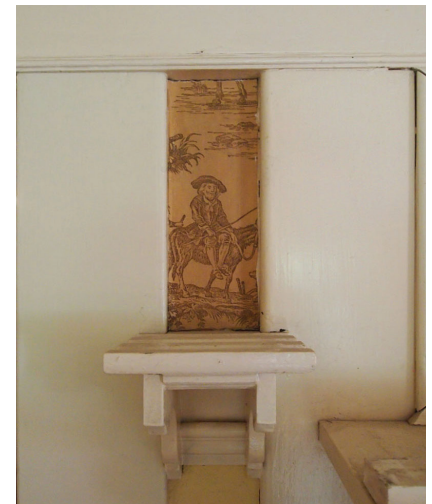
Don Quixoté shrine

there is built-in hutch which is exquisitely incorporated into the adjacent door frame design. Within this framing of the hutch to the doorway there appears to be a whimsical shrine to perhaps Don Quixote (sitting cross-saddle) of repurposed wall paper. Along the perimeter walls is a plate rail. All walls have wallpaper with the wall below the plate rail having a diamond textured or patterned wallpaper. This room is also in excellent condition with the exception of some water damage to the wallpaper in the corners, and a slight deflection to several of the ceiling beams probably caused by the condition of the roof framing above.

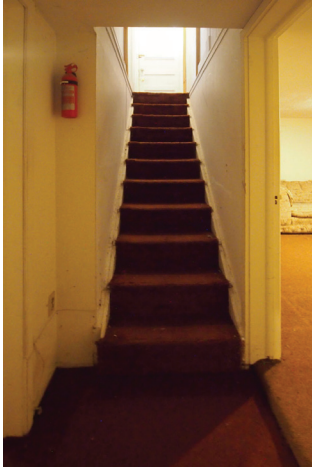
Basement Stair

corner is a door which leads to the **Basement Stair**. There is also an exterior door on the west elevation which opens on to this same space. The stairway to the basement is narrow and steep. It is not built to either residential, or commercial, building code requirements. This current stair does not have any handrails.
