# FLH CULVERT ASSESSMENT FORM

## Inspection Report / Inspection: 1

| Street<br><b>153+25</b> | Use of Sewer<br><b>Stormwater</b> | Upstream MH<br><b>INLET-W</b> |
| City<br><b>Port Angeles</b> | Drainage Area | Downstream MH<br><b>OUTLET</b> |

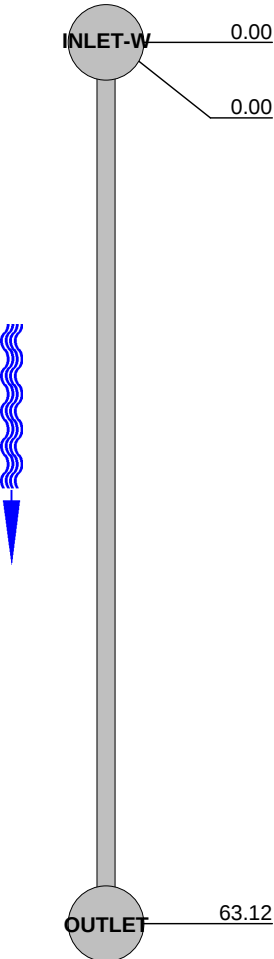
| 1:165 | Position | Observation | MPEG | Photo | | | |
|---|---|---|---|---|---|---|---|
| | 0.00 | Water Level, 5 %of cross sectional area | | | | | |
| | 0.00 | End of Pipe / INLET-W | 00:00:00 | | | | |
| | 63.12 | End of Pipe / OUTLET | 00:07:49 | INLET-W_OUTLET103021_19<br>052011_A.JPG | | | |
