1011  
ALASKA  
Job Corps Center  
Palmer, AK

Facility Planning Report  
Volume I  
Planning Strategy

Final  
May 2016

Department of Labor/ Office of Job Corps

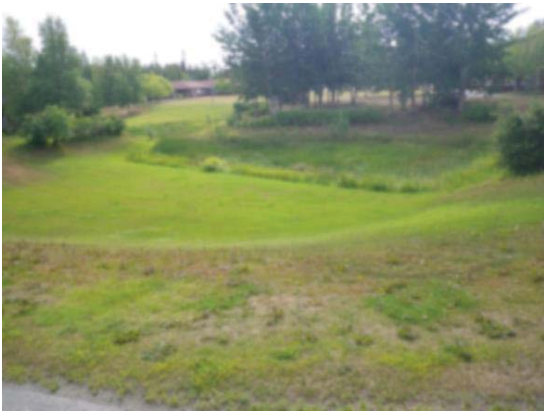
**View of Water Detention Pond**

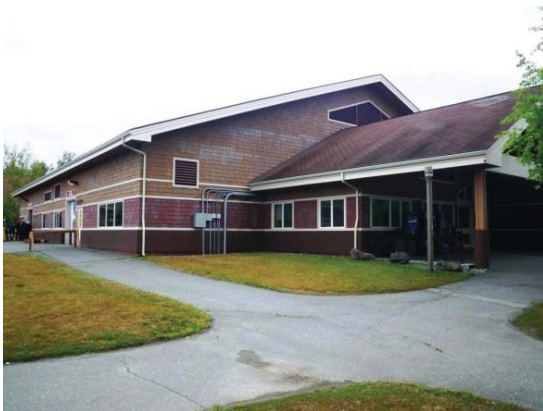
Vocation/Education Building 2

The Center buildings are either steel or wood framed. The exterior walls have Exterior Insulation and Finish System (EIFS) panels at the lower half and painted wood shingle siding above. At most of the buildings, and in various degrees, the finish of the wood shingles has faded, leaving the shingles exposed to the elements. The asphalt shingle roofs on most of the Center buildings were replaced in 2015 with new asphalt shingled roofs. Aside for the faded paint on the siding the buildings are in good condition.

NATIONAL PROJECT # 3704  
REPAINT EXTERIOR SIDING  
OF CENTER BLDG'S  
1, 2, 3, 4, 5, 6, 7 & 8

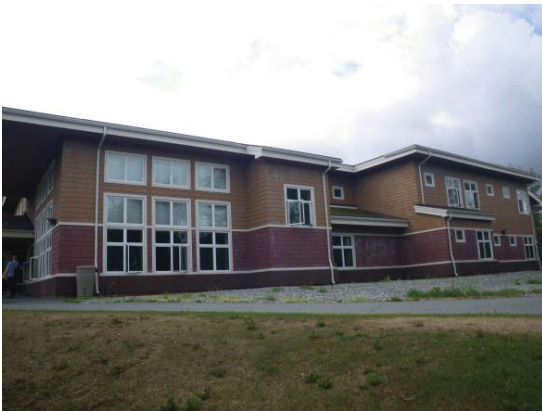
**Male Dormitory Building 6**

The dormitory buildings are adequate, function well, and in good condition.

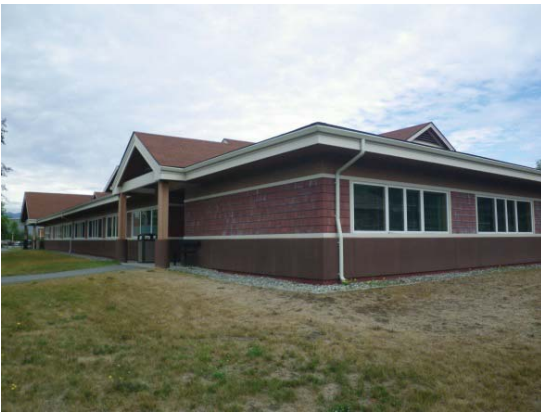
**Vocation/Education Building 2**

The educational and vocational buildings are adequate in size, function well, and in good condition.

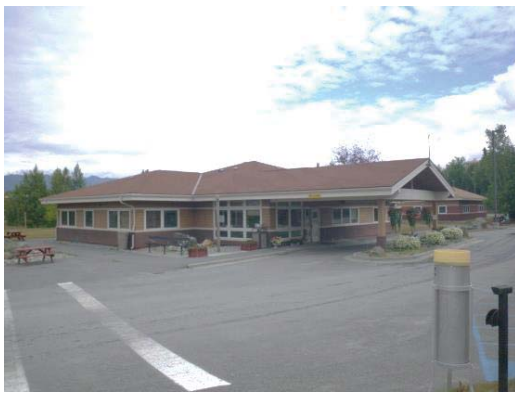
**Administration/Health Services Building 1**

the building perimeter, and benefit from natural light and ventilation. This building is in good condition, and functions well.
