# WATERFRONT STRUCTURES AT WHITE BEACH FUEL PIER AND TENGAN SMALL CRAFT BERTH 2018 INSPECTION

## 1. EXECUTIVE SUMMARY

**General Project Description:** The U.S. Army Corps of Engineers (USACE) Dive Team performed a visual and tactile inspection of all above water and underwater waterfront structures and adjacent bank lines of the berthing areas at the White Beach Fuel Pier and Tengan Small Craft Berth and Seawalls in Okinawa, Japan, from April 5 to 18 2018. The structures inspected included: 1,728 LF of Fuel Pier, 250 ft of tetrapod wave protection on the shore end of the pier at White Beach, and 1,200 LF of tetrapod protected concrete seawall, 2100 SF of boat ramp, 800 LF of pile and cap wall, 225 LF of coral/stone wall and 186 LF of concrete block wall at the Tengan Small Craft Basin and Seawalls.

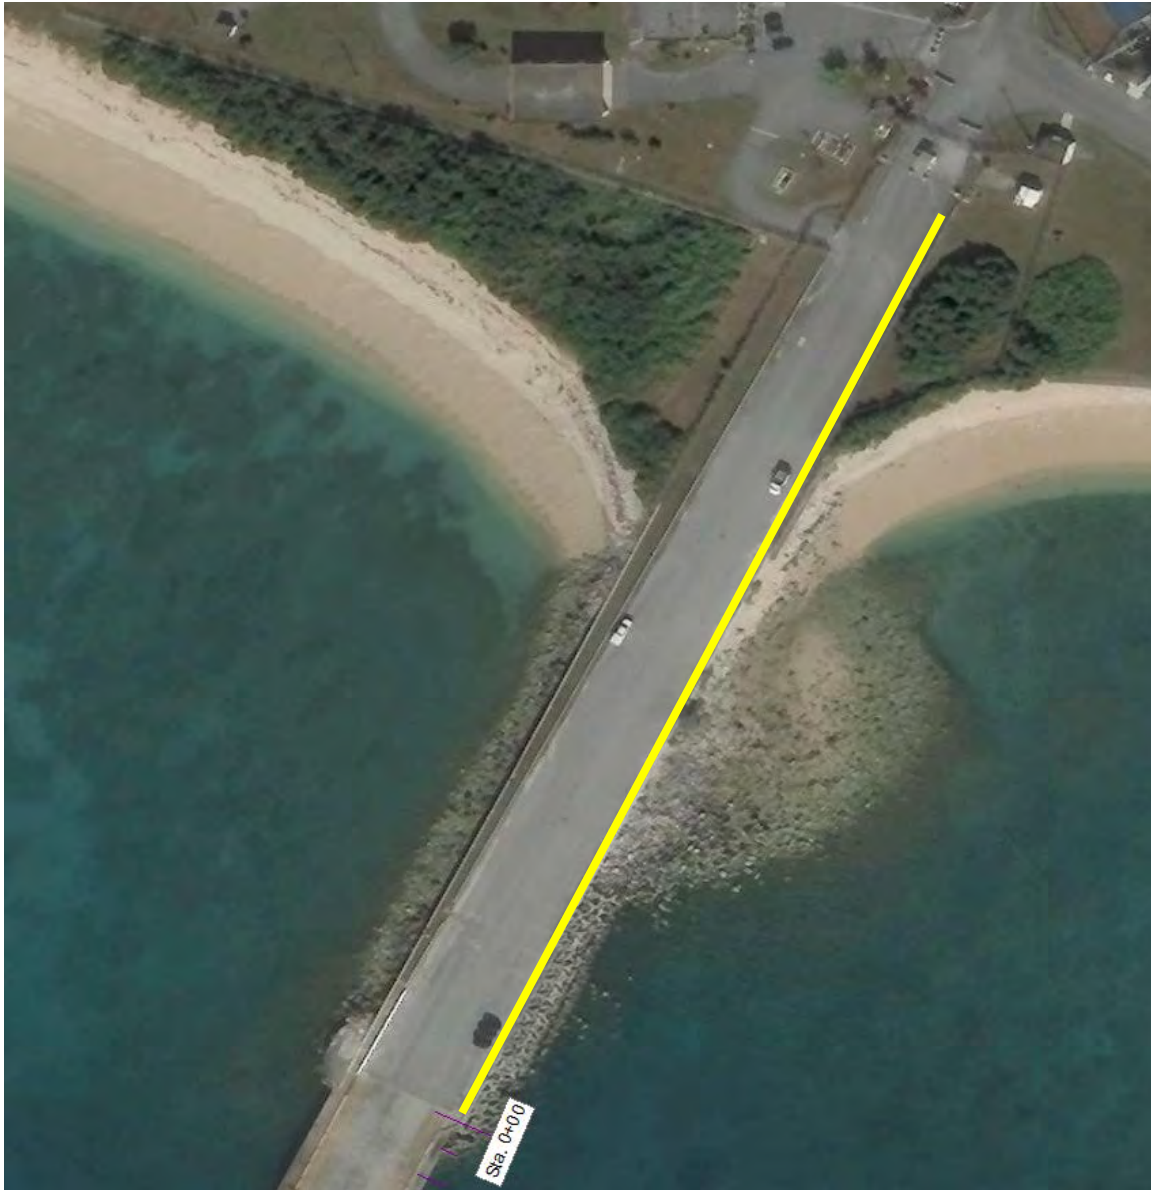
**Figure 6-1. Aerial View of Shore Attached Causeway**

**B. White Beach: Shore Attached Causeway****CONDITION RATING - 4**

The overall condition of the Shore Attached Causeway is **Fair**. Figure 6-1 presents an aerial view of the causeway showing the condition rating. Out of the 13 fence posts on the causeway on the east side 12 show signs of corrosion of the reinforcing steel and cracks in the concrete, with an additional 8 damaged in a similar fashion on the west side, one of which has had the foundation of the post fail, leaving the chain mesh supporting the post. The chain mesh is firmly attached to all posts on the east side, but the retaining wires have corroded to failure on 7 of the posts on the west side. The tetrapod wave protection installed on the eastern face of the causeway has shifted significantly since

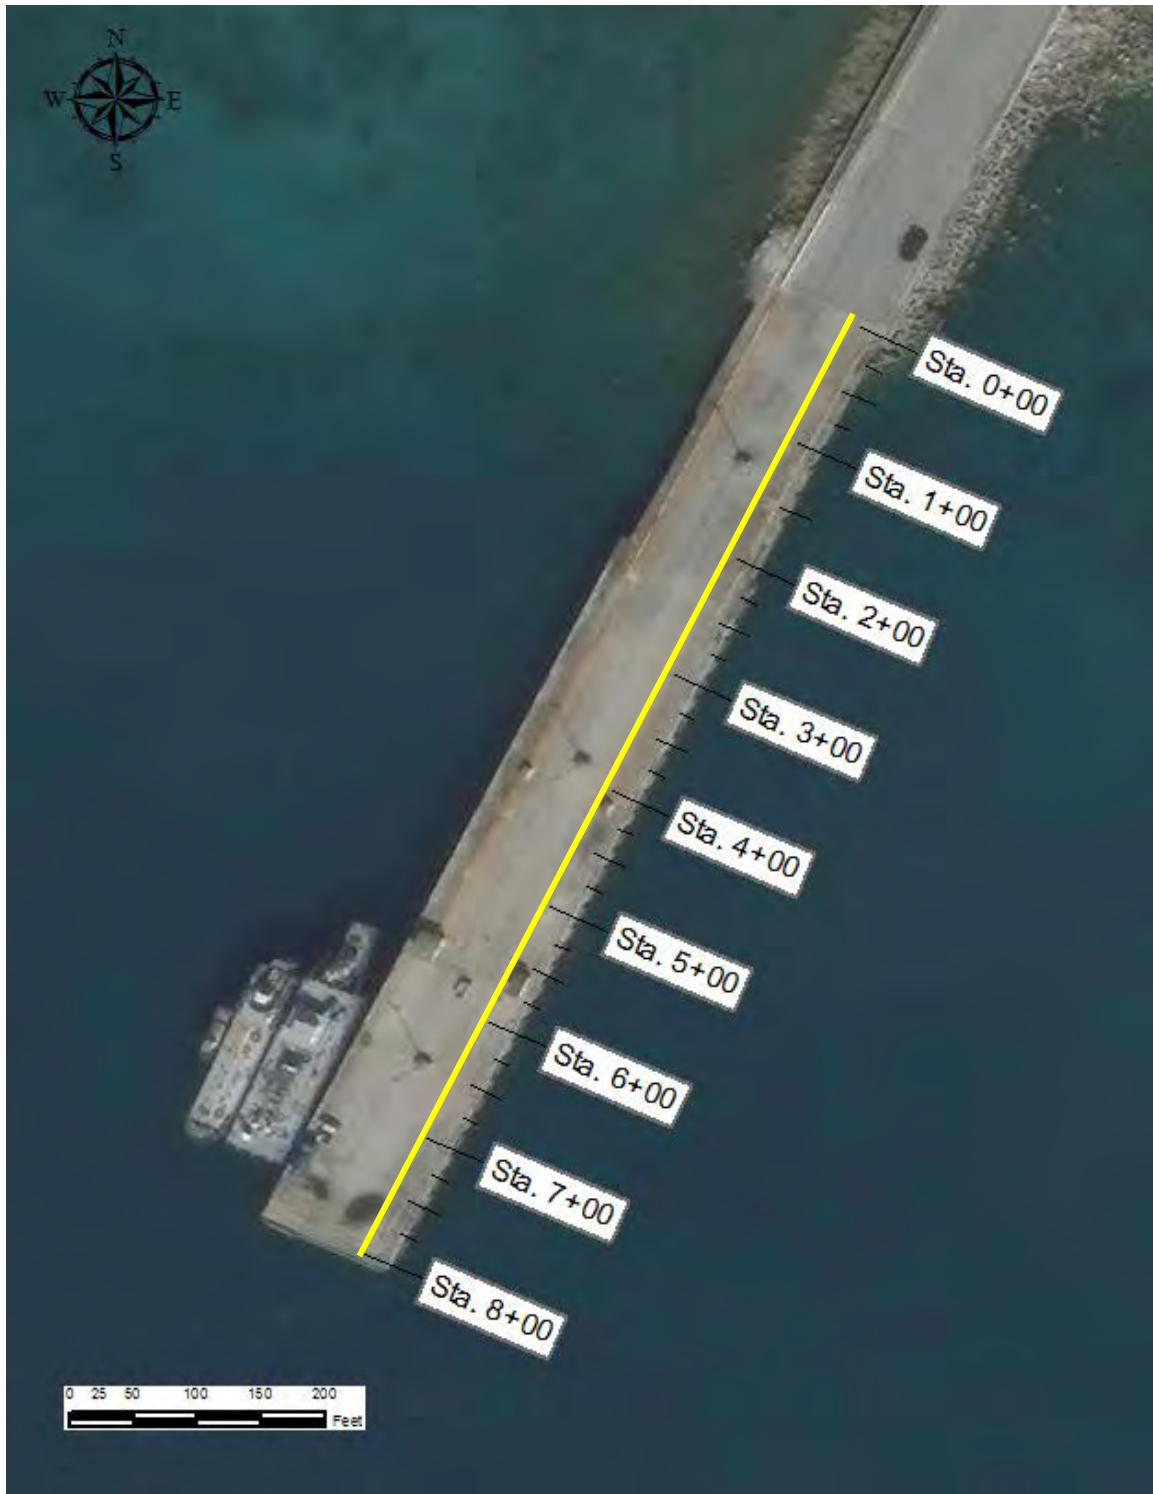
Figure 6-2. Aerial View of the White Beach Fuel Pier

CONDITION RATING - 4

The overall condition of the White Beach Fuel Pier is **Fair**. Figure 6-2 presents an aerial view of the berthing facility showing the condition rating. The unknitting of the tetrapods has reduced their resistance against wave action and left them vulnerable to additional shifting and degradation as well as exposing the underlayer. Extensive patching of the holes in the SSP noted in the last inspection was completed in 2016, however a number of smaller holes are still present and a 4" wide gap between adjacent sheets is open at pile A13 (Station 4+34). The bullrails on the pier have been recently replaced and are in good condition, and extensive repairs have been completed on the deck. These concrete repairs are generally in good condition with minor map cracking present in some areas. A summary of the GPS coordinates, Overall Condition Rating, and the Facility Operational Rating are presented in Table 6-3.

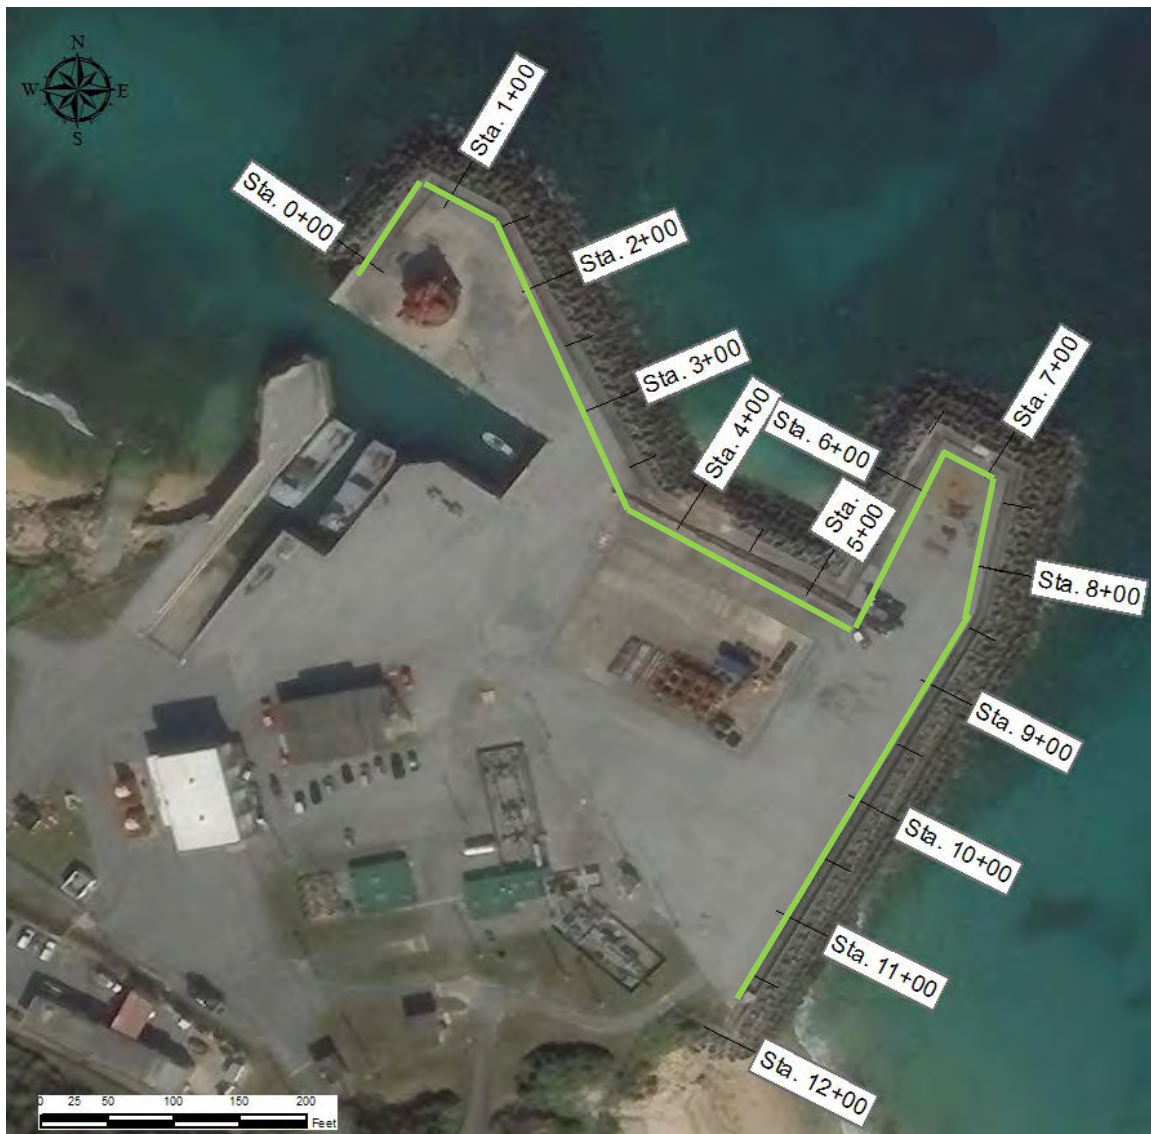
**Figure 6-3. Aerial View of Tengan Small Craft Basin Seawall at CWTF#3 (15431)**

**D. Tengan Small Craft Basin Seawall at CWTF#3 (Fac. Num: 15431)****CONDITION RATING - 5**

The overall condition of the Tengan Small Craft Basin Seawall is Satisfactory. Figure 6-3 presents an aerial view of the seawall showing the condition rating. A summary of the GPS coordinates, Overall Condition Rating, and the Facility Operational Rating are presented in Table 6-5.

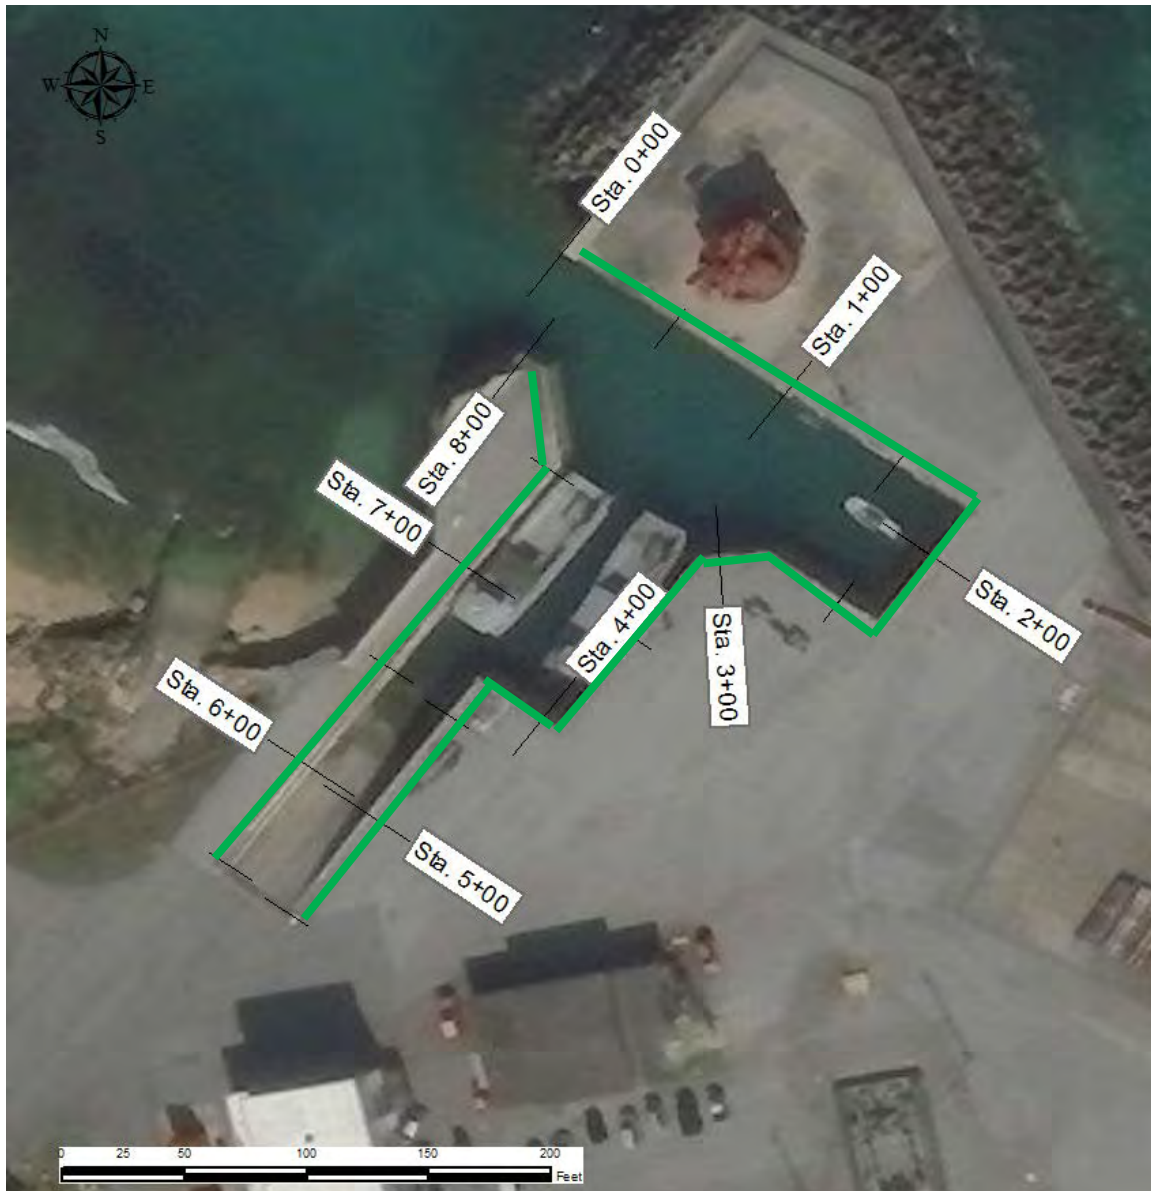
Figure 6-4. Aerial View of the Tengan Small Craft Berth (Fac. Num: ~~312SM~~)

CONDITION RATING - 6

The overall condition of the Small Craft Berth is **Good**. Figure 6-4 presents an aerial view of the berthing facility showing the condition rating. Sedimentation has resulted in a total water depth 6 to 8 ft at the entrance at low tide. The sand bottom rapidly slopes to a depth of between 12 to 14 ft in the areas immediately adjacent to the berthing wall. A summary of the GPS coordinates, Overall Condition Rating, and the Facility Operational Rating are presented in Table 6-7

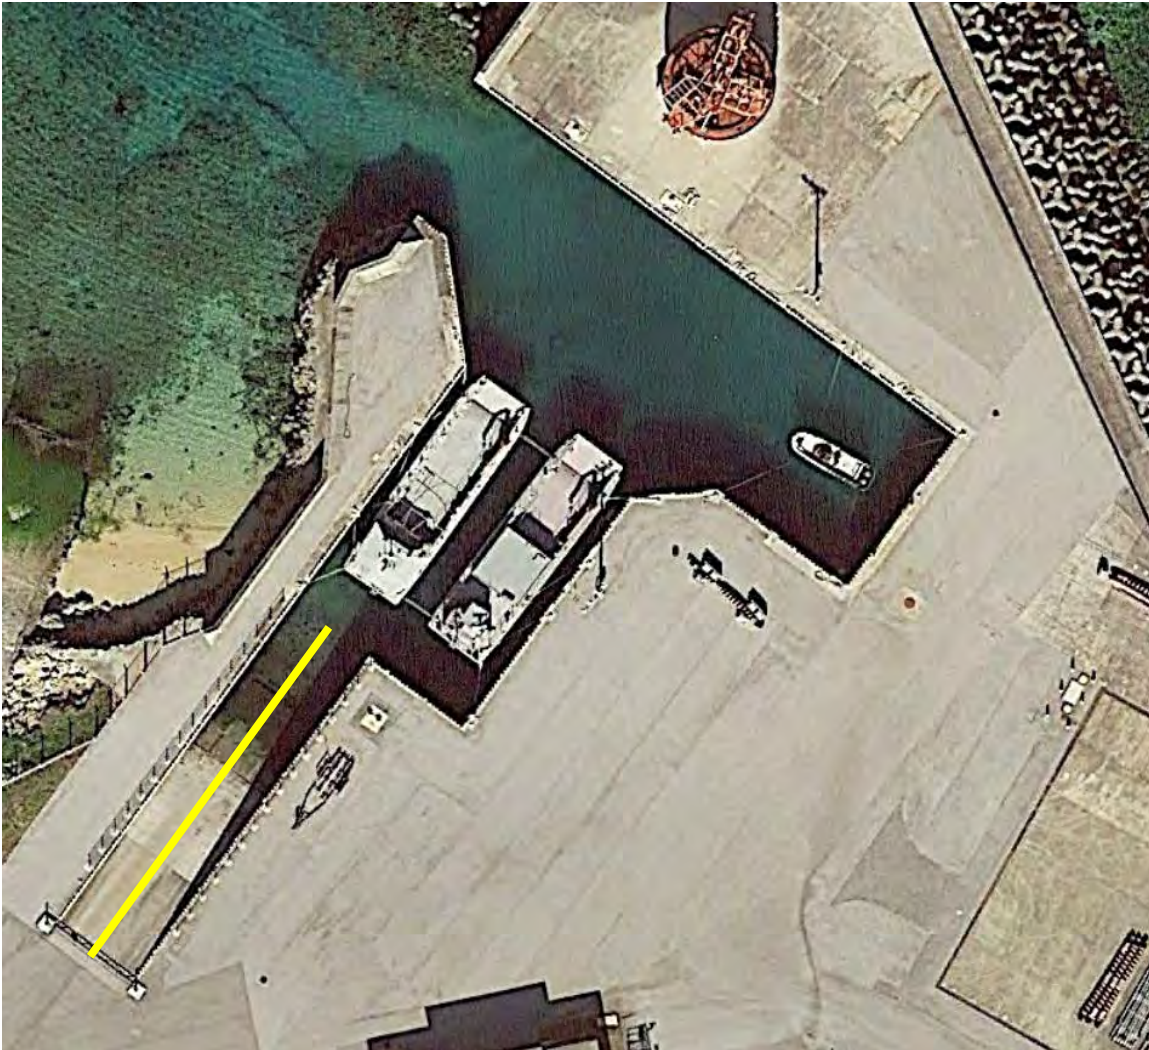
Figure 6-5. Aerial View of the Tengan Small Craft Berth Boat Ramp (Fac. Num: ~~312SM~~ 312BR)

**F. Tengan Small Craft Berth Boat Ramp (Fac. Num: 312BR)****CONDITION RATING - 4**

The overall condition of the Boat Ramp is **Fair** due to the settlement of the pre-cast concrete blocks that form the ramp. Figure 6-5 presents an aerial view of the berthing facility showing the condition rating. A summary of the GPS coordinates, Overall Condition Rating, and the Facility Operational Rating are presented in Table 6-9.

REPAIR ITEM NO.	REPAIR PRIORITY	PHOTO NO. (APP. A)	DAMAGE DESCRIPTION	QUANTITY	REPAIR DESCRIPTION
T_BR	H	303,304, 305,306	Settling of ramp at lower end had resulted in a 4" dropoff and shifting of the ramp slabs	Typ	Repair settling via injected flowable fill or resetting blocks

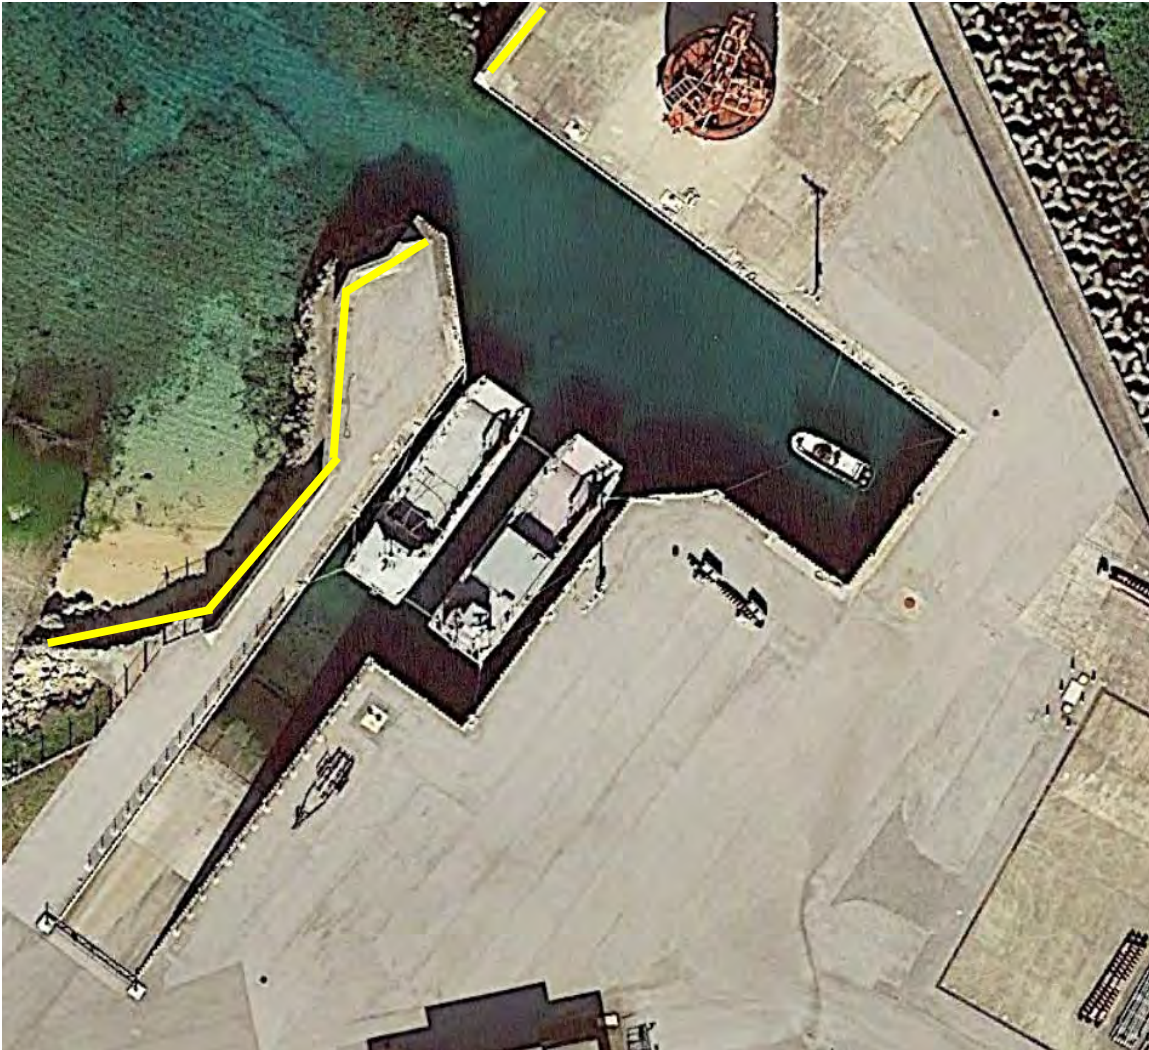
**Figure 6-6. Aerial View of Tengan Small Craft Berth Seawall (Fac. Num: 312SW)**

**G. Tengan Small Craft Berth Seawall (Fac. Num: 312SW)****CONDITION RATING - 4**

The overall condition of the Small Craft Berth Seawall is **Fair** due to the loss of concrete in the coral seawall foundation as well as corrosion of the reinforcing steel in the fence posts adjacent to the seawall. Figure 6-6 presents an aerial view of the seawall showing the condition rating. A summary of the GPS coordinates, Overall Condition Rating, and the Facility Operational Rating are presented in Table 6-11.
