315 Earle C. Clements Job Corps Center Morganfield, KY

Facility Planning Report Volume I Planning Strategy

Final June 2011

Department of Labor/ Office of Job Corps

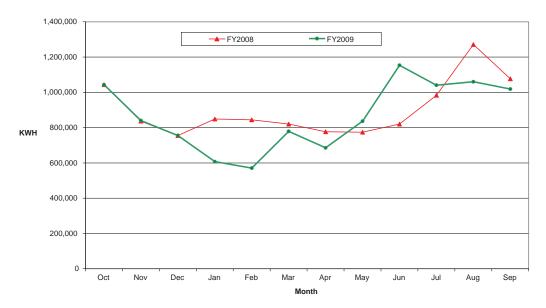
Chart 1: E C Clements JCC Electricity Use

In FY 2009, EC Clements JCC decreased electricity consumption by 4.2% compared to FY 2008. Cooling degree days decreased by 7.4% during the period, which explains the drop in usage. Electricity use for FY 2008 and FY 2009 is shown below in Chart 1.

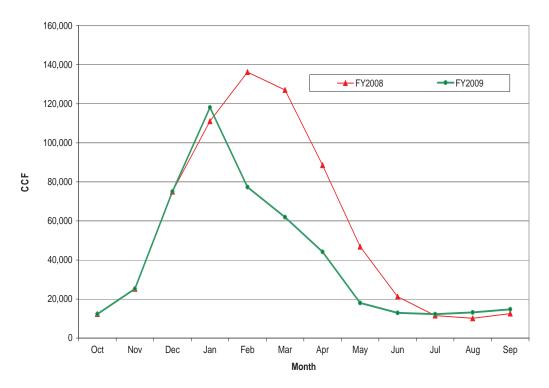
Chart 2: E C Clements JCC Natural Gas Use

Natural gas usage decreased by 28.4%, from FY 2008 to FY 2009. Heating degree days increased 2.1% during the period, so the center is to be commended for reducing usage in spite of the increased demand. Chart 2 shows natural gas use for FY 2008 and FY 2009.

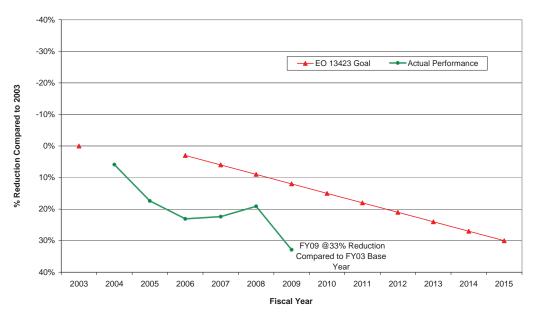
Chart 3: E C Clements JCC Progress toward EO 13423 Energy Goals

The FY 2003 energy consumption baseline for EC Clements is 155,123 BTU/GSF. The EO 13423 target is for a 12% reduction in FY 2009 which would be 136,508 BTU/GSF. The center posted a consumption of 104,071 BTU/GSF in FY 2009, which represents a substantial 32.9% reduction relative to the baseline. Chart 3 below shows yearly energy consumption at EC Clements relative to FY 2003. The red line represents the reduction target, and as long as the green line (which represents consumption) stays below the red line the target has been achieved.

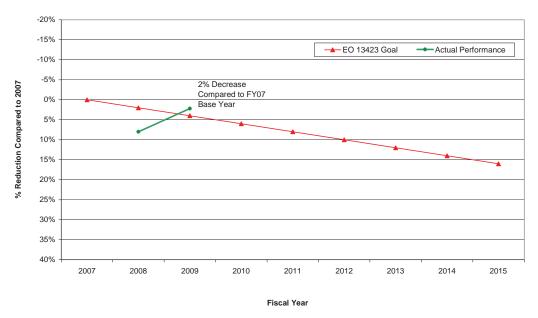
Chart 4: E C Clements JCC Progress toward EO 13423 Water Goals

The FY 2007 water consumption baseline for EC Clements is 70.49 GAL/GSF. The target for FY 2009 is a 4% reduction relative to the baseline, or 67.67 GAL/GSF. Unfortunately, the center posted only a 2.2% decrease relative to the baseline in FY 2009, with a consumption of 68.92 GAL/GSF. Water consumption relative to FY 2007 is shown below in Chart 4. The red line represents the EO 13423 target, and the green line (consumption) must be below the red line in order for the target to be met.

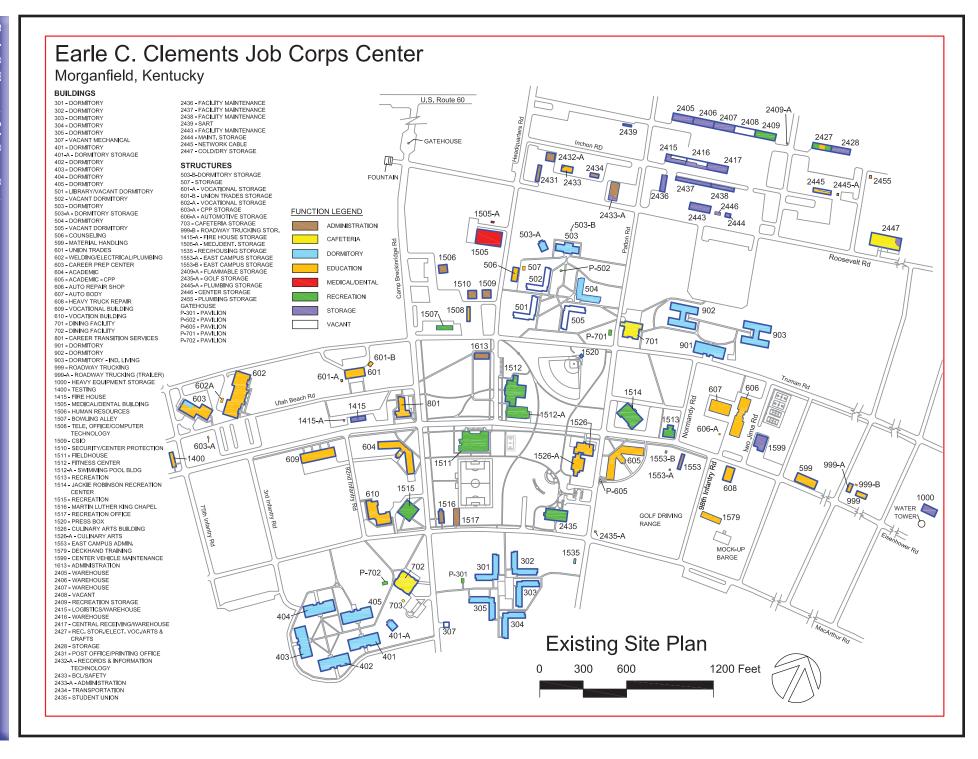
# EARLE C. CLEMENTS JOB CORPS CENTER DEVELOPMENT PLAN

This proposed development plan is described further on the following pages through a proposed site plan and an implementation plan.
